**AGENDA**  
**CODE ENFORCEMENT & APPEALS BOARD HEARING**  
**MAY 2, 2018**  
**5:30 PM**  
**CITY HALL COMMISSION CHAMBERS**  
**204 ASH STREET**  
**FERNANDINA BEACH, FL 32034**

- 3.1 **RICHARD GOODSSELL, FRONT STREET PROPERTY LLC, 101 NORTH 2ND STREET, CASE 18-00044.** Violation(s) of the City of Fernandina Beach Code of Ordinances exist: Section 42-116 (a & b), cleaning of lots; maintenance of structures. *Requesting Board determination of the case.*

This property has been on the City's radar for quite some time, years. Many conversations have transpired between the City and Mr. Goodsell over the last few years about the condition of the building and the future of this property.

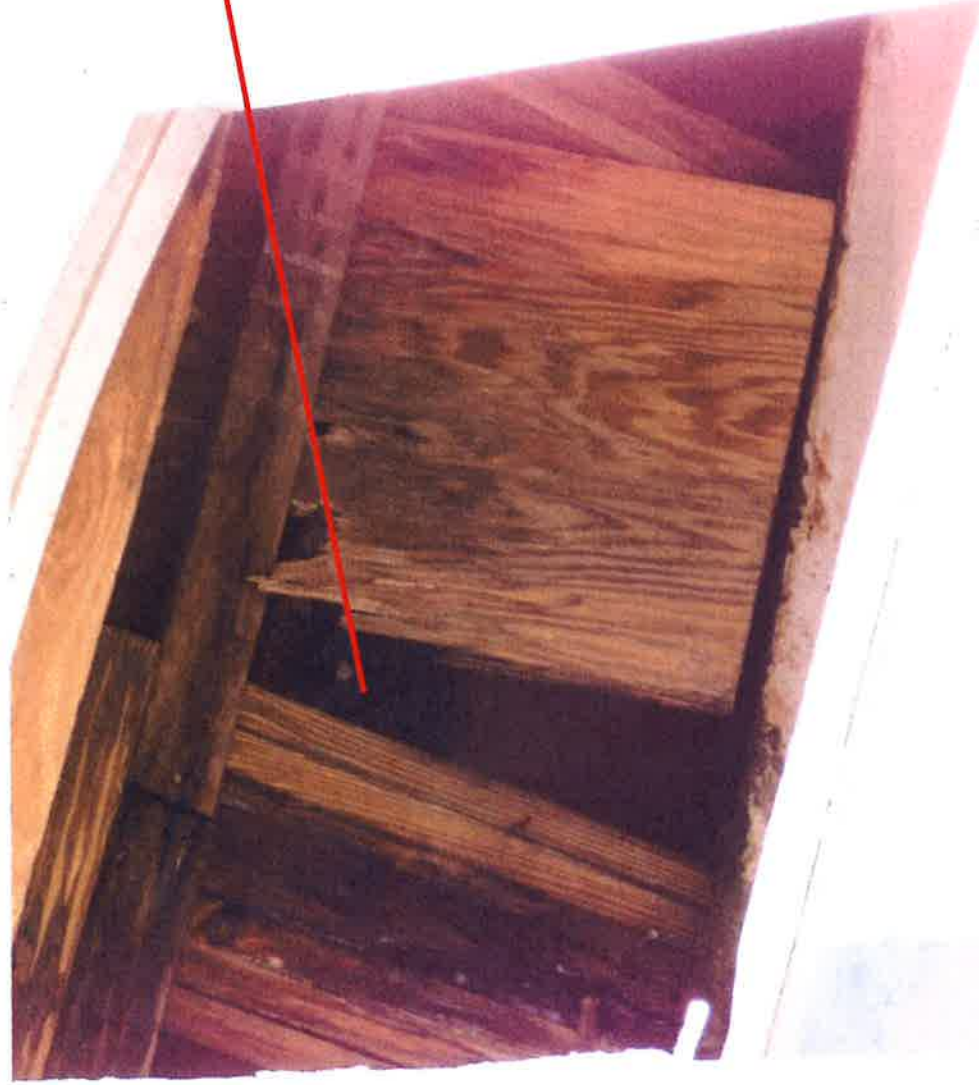
Roof failure as  
seen through  
open window

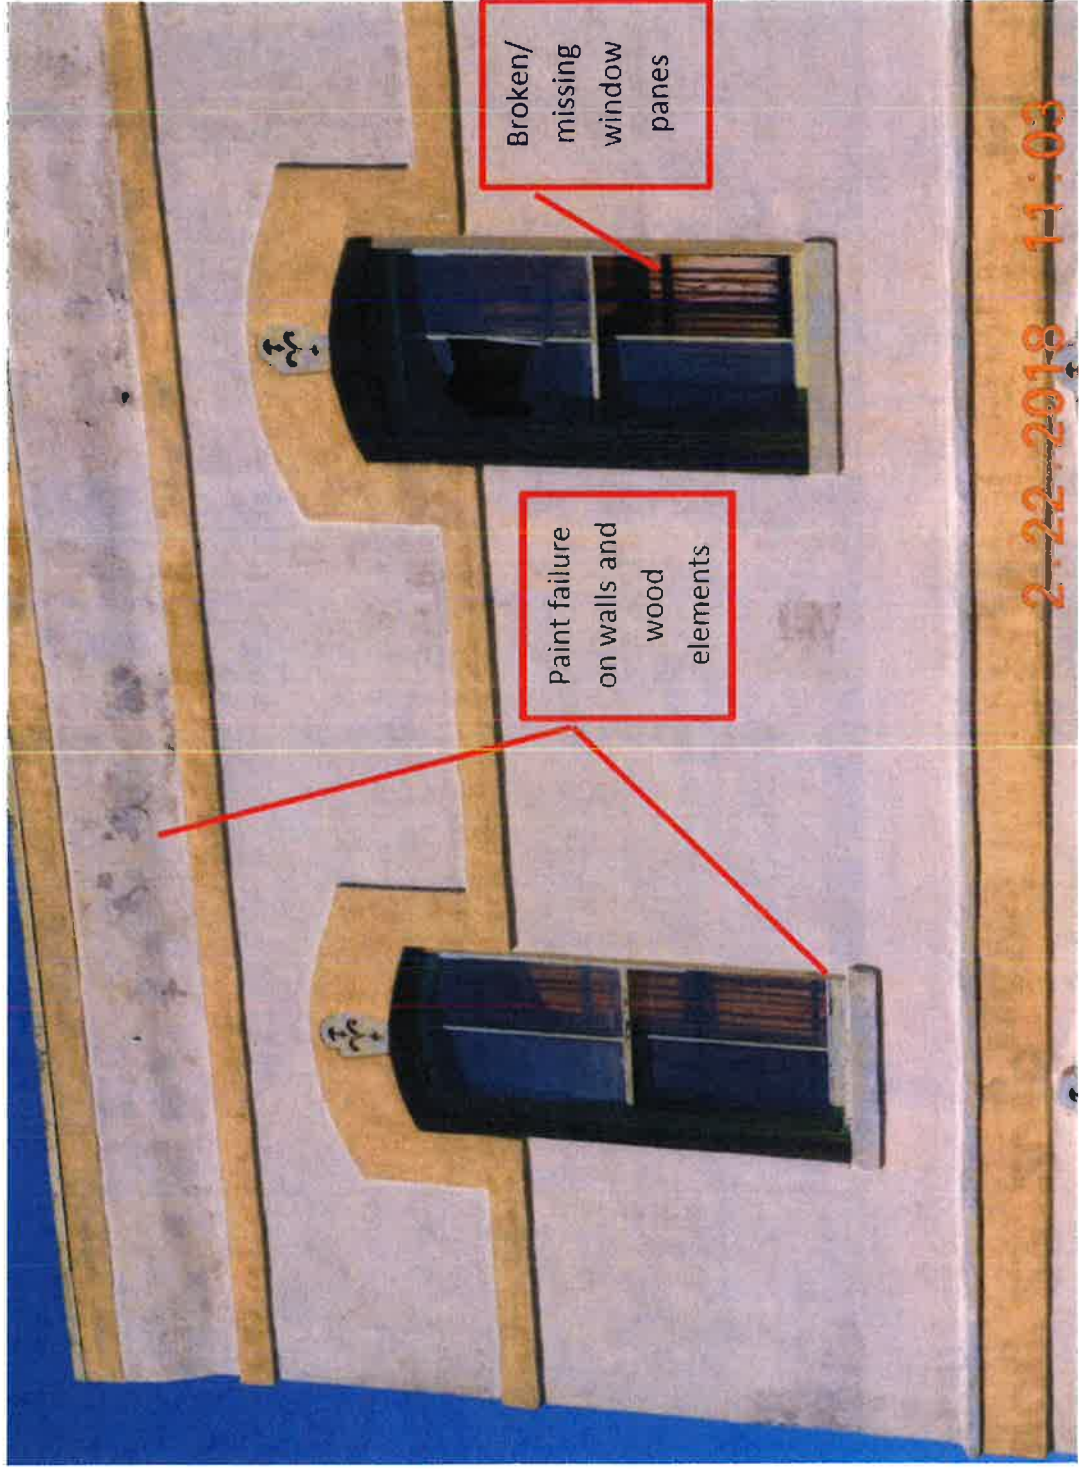
Broken/  
missing  
window  
panes

Paint failure  
on walls and  
wood  
elements

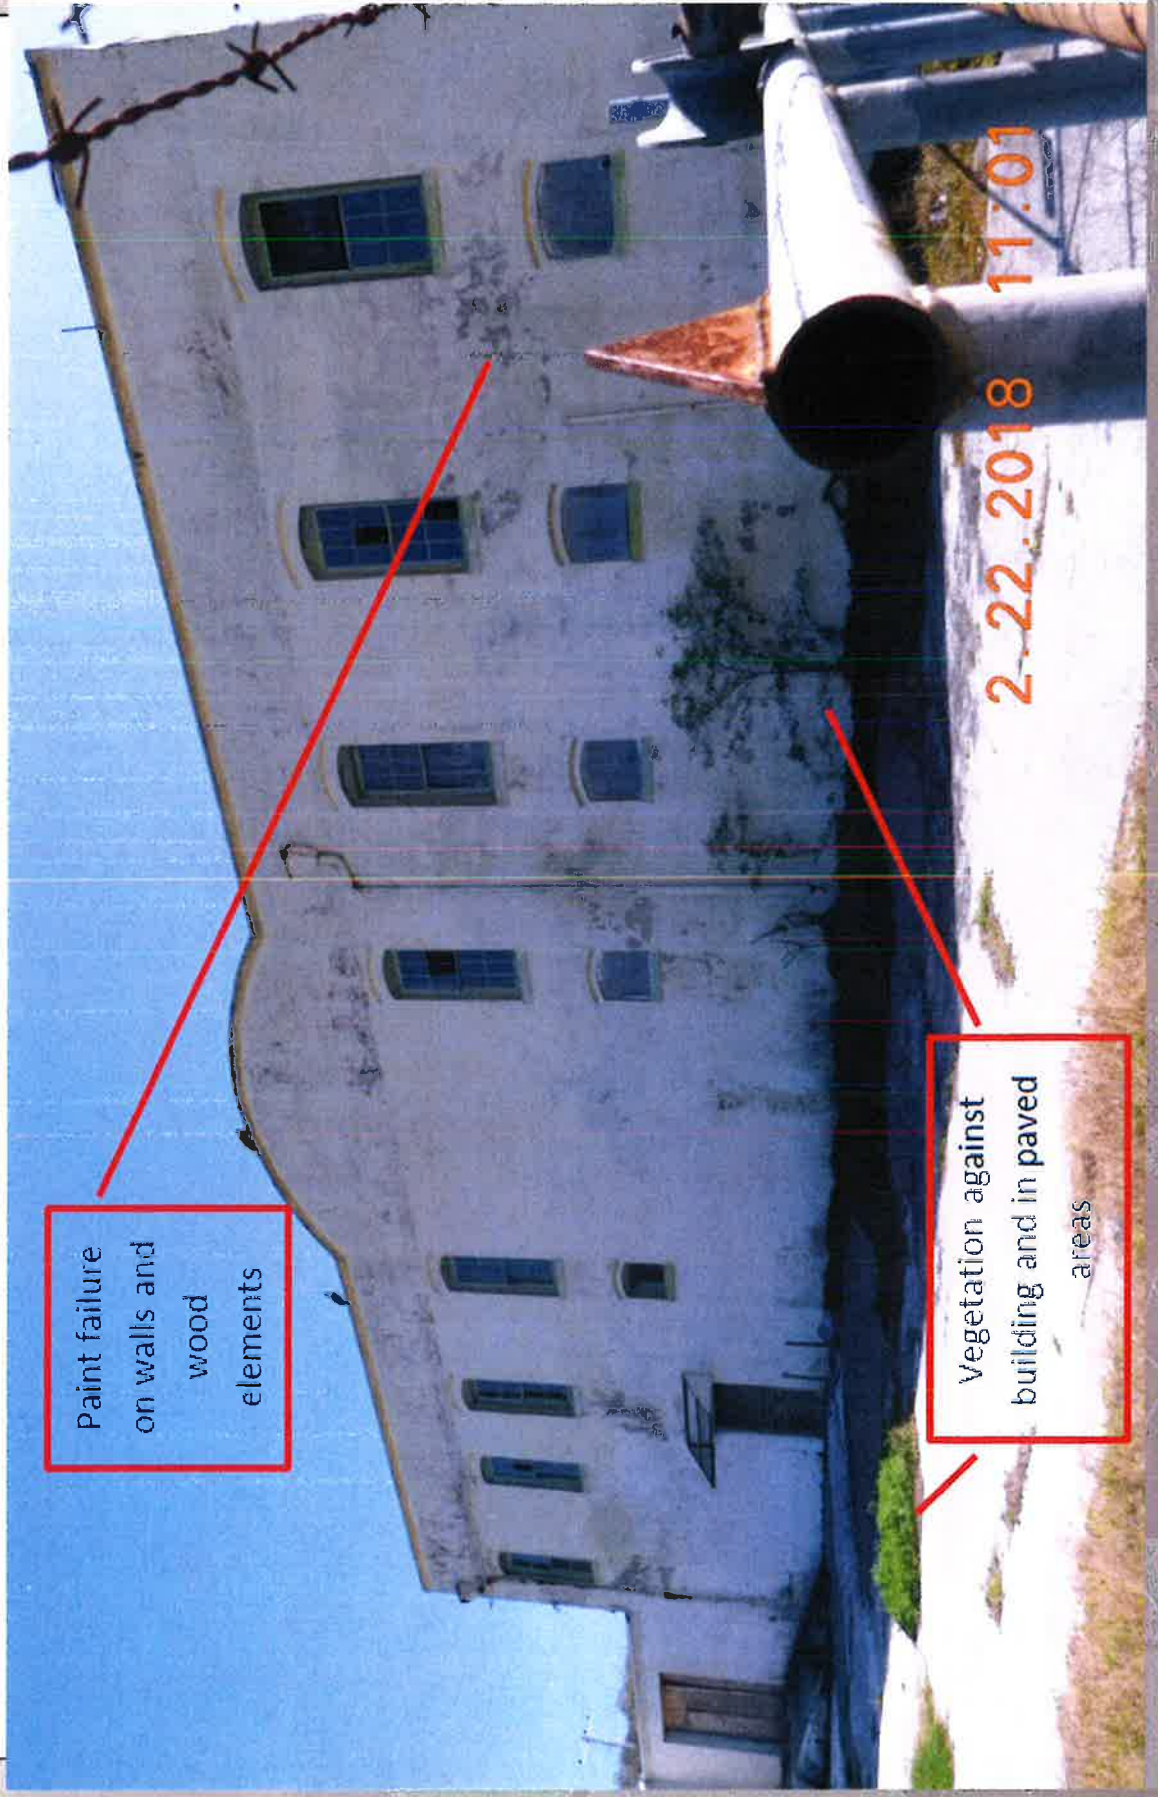
Paint failure  
on walls and  
wood  
elements

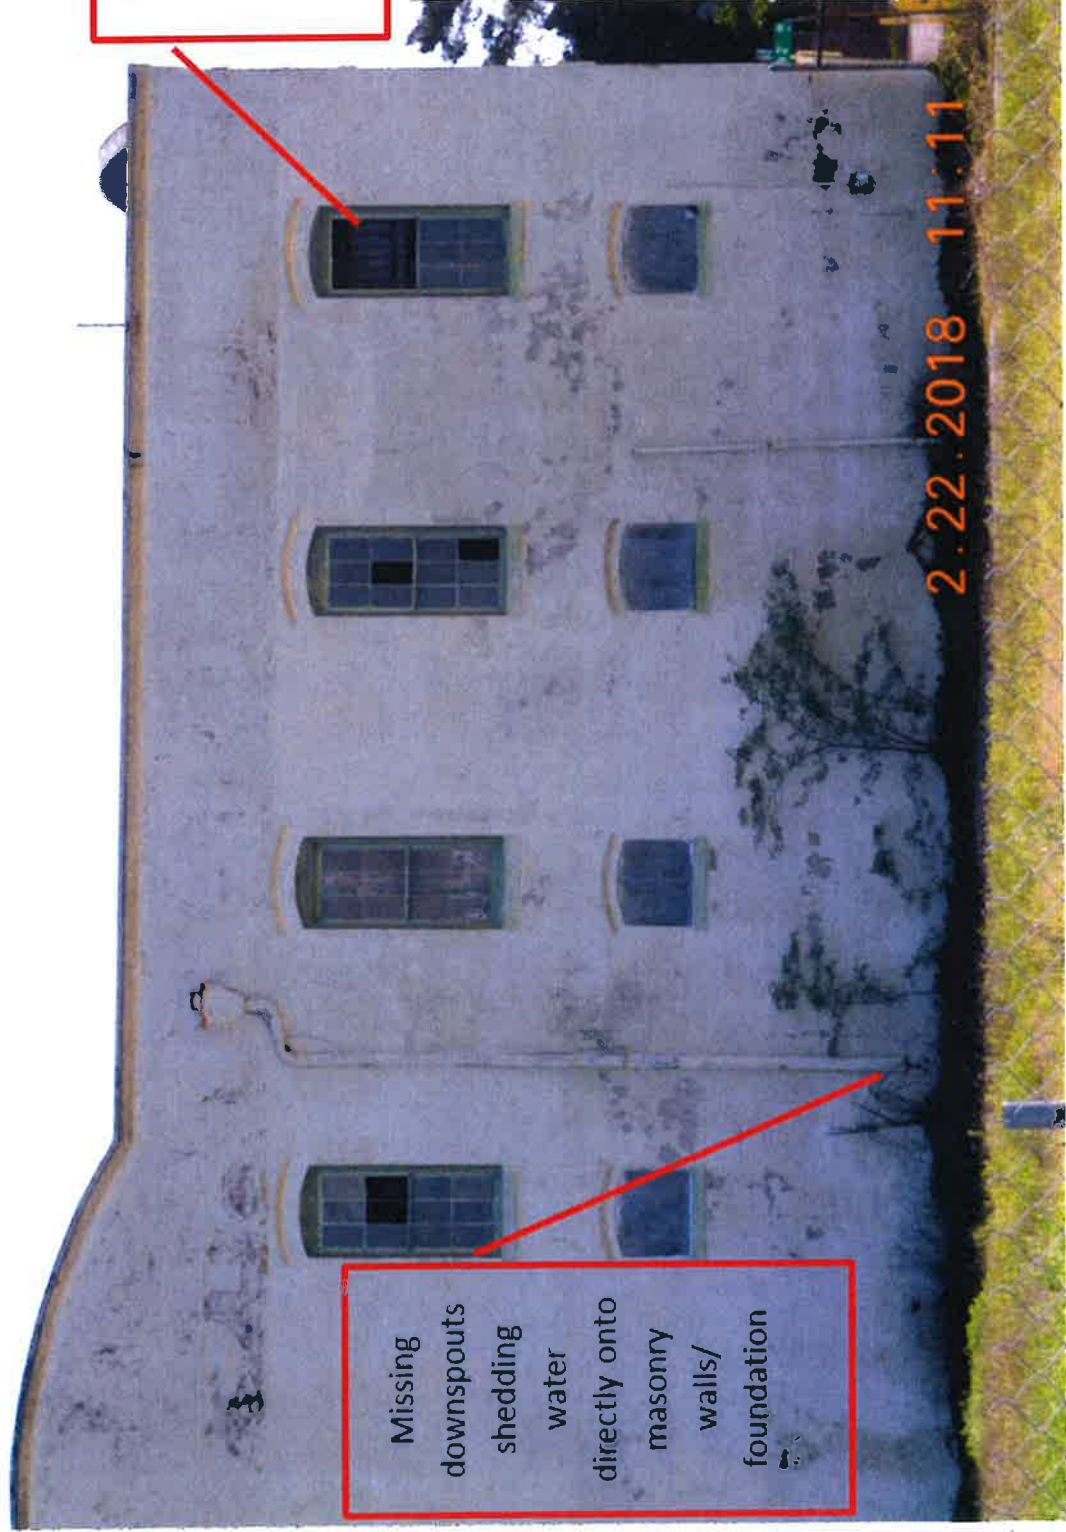
Multiple  
broken/  
missing  
window  
panes

Missing  
downspouts  
shedding  
water  
directly onto  
masonry  
walls/  
foundation

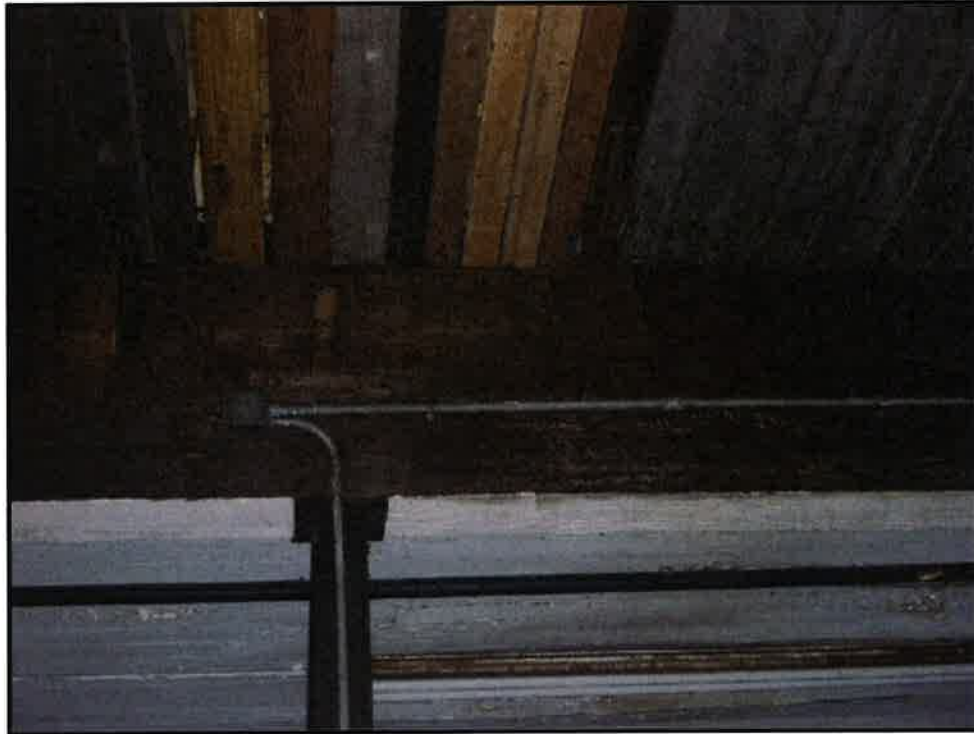
Photo 3 – Wood beam above first floor still in good condition.
