**AGENDA  
AIRPORT ADVISORY COMMISSION  
REGULAR MEETING  
NOVEMBER 14, 2019  
6:00 PM  
CITY HALL COMMISSION CHAMBERS  
204 ASH STREET  
FERNANDINA BEACH, FL 32034**

# Executive Summary

Fernandina Beach Municipal Airport was inspected in May of 2019 – the overall weighted PCI value was 69, a condition rating of Fair. The results of the maintenance, repair, and major rehabilitation analysis identified \$759,600 in localized M&R needs based on current conditions and a 10-Year major rehabilitation need of \$12,252,000 based on forecasted conditions. The current major rehabilitation needs based on the latest inspection consist of \$9,939,000 for pavements below critical condition.

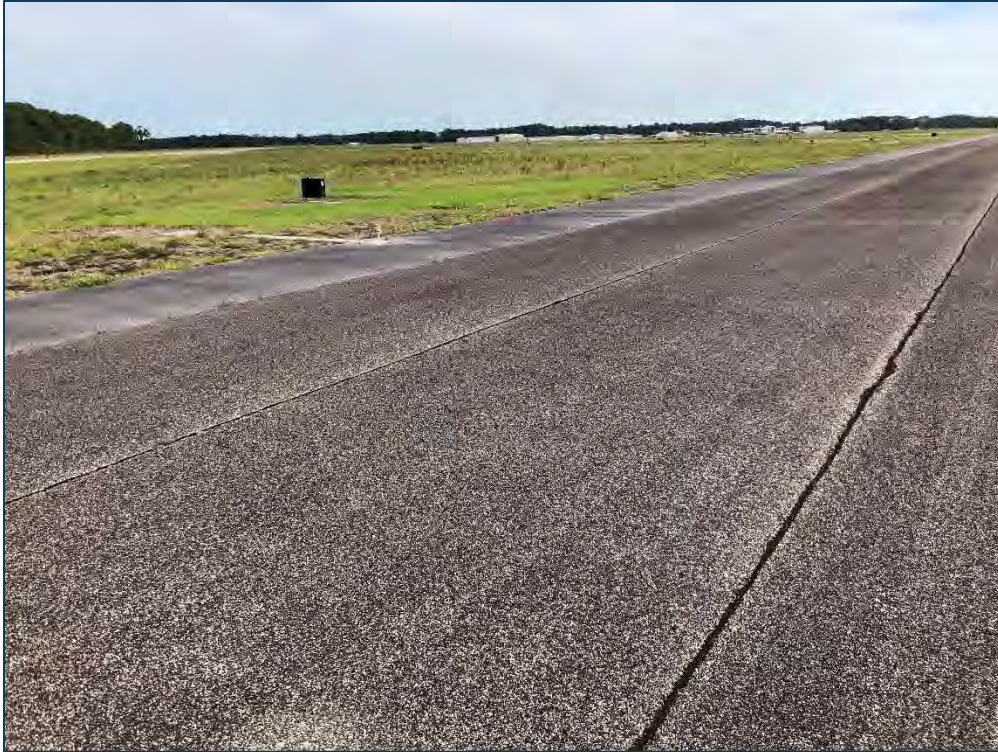
RW 4-22, Section 6105, Sample Unit 108 - Low Severity (48) Longitudinal & Transverse Cracking, Low Severity (52) Raveling, and Low Severity (57) Weathering

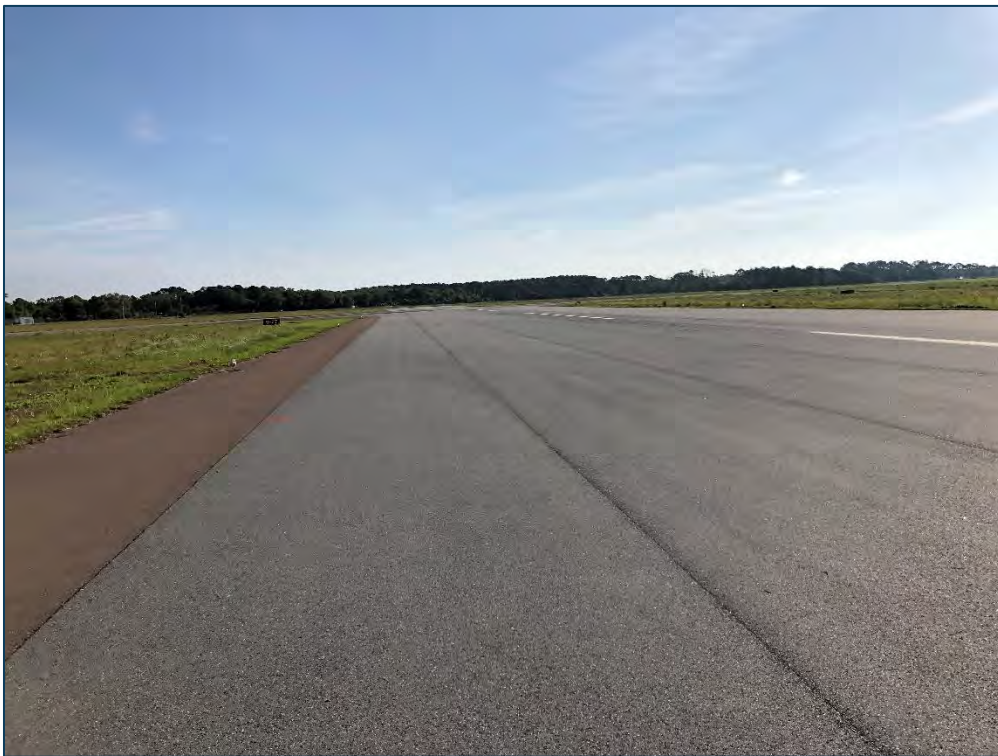
RW 4-22, Section 6110, Sample Unit 177 - Low Severity (48) Longitudinal & Transverse Cracking and Low Severity (57) Weathering

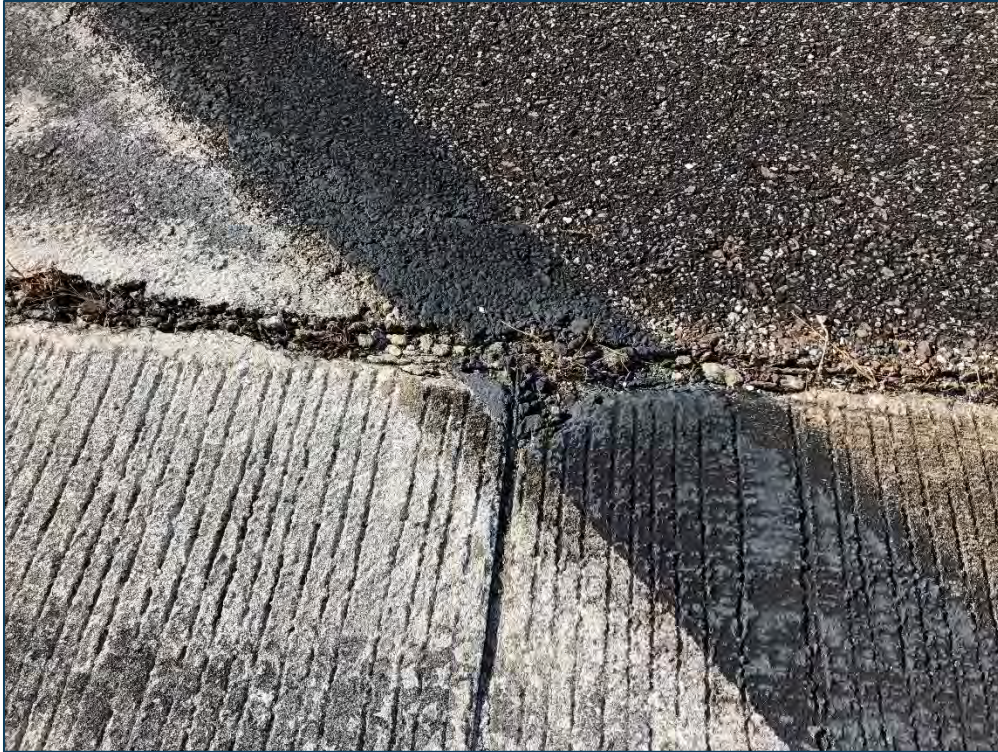
RW 9-27, Section 6305, Sample Unit 309 - Low Severity (65) Joint Seal Damage and Low Severity (75) Corner Spall

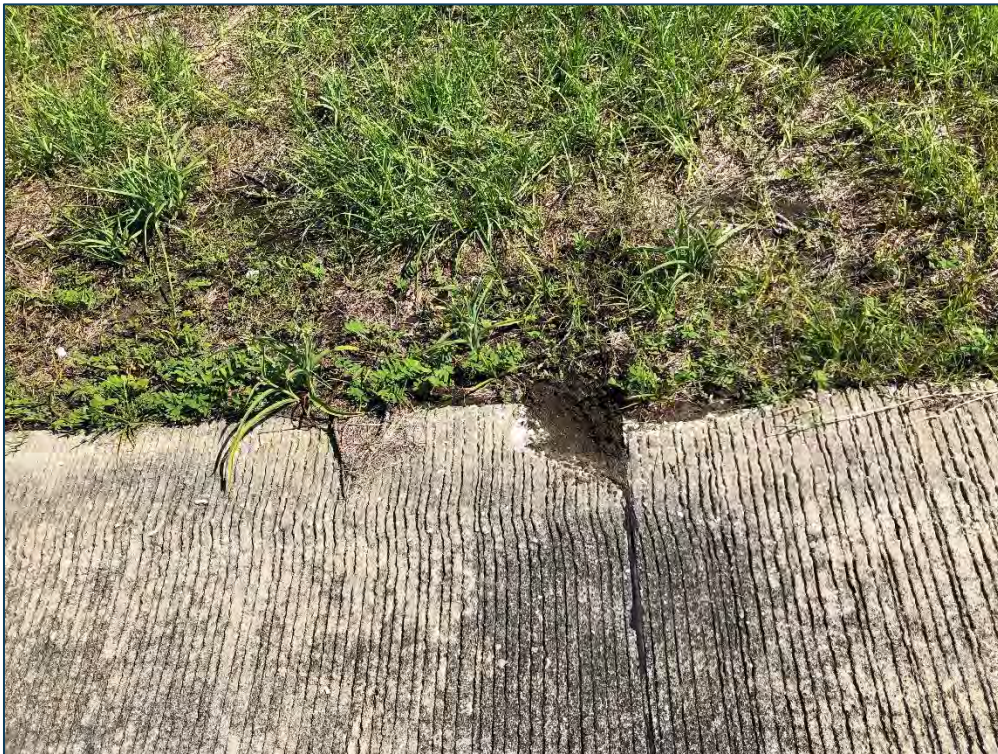
RW 9-27, Section 6335, Sample Unit 406 - High Severity (65) Joint Seal Damage and Medium Severity (75) Corner Spall

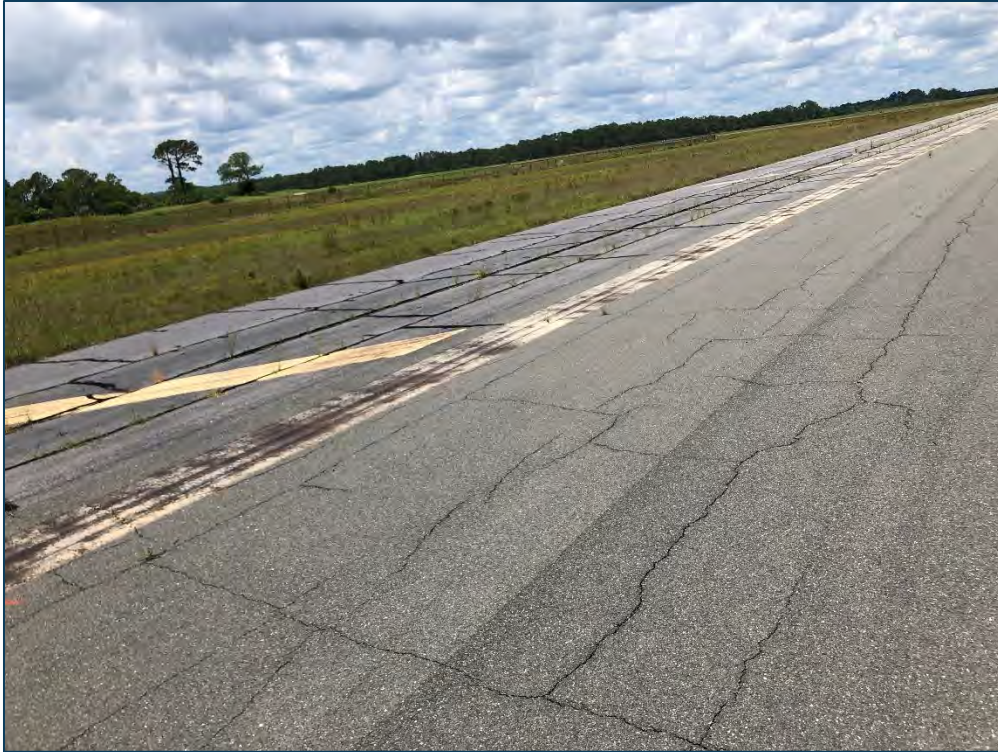
RW 13-31, Section 6215, Sample Unit 329 - Low Severity (43) Block Cracking, Low Severity (48) Longitudinal & Transverse Cracking, and Low Severity (57) Weathering

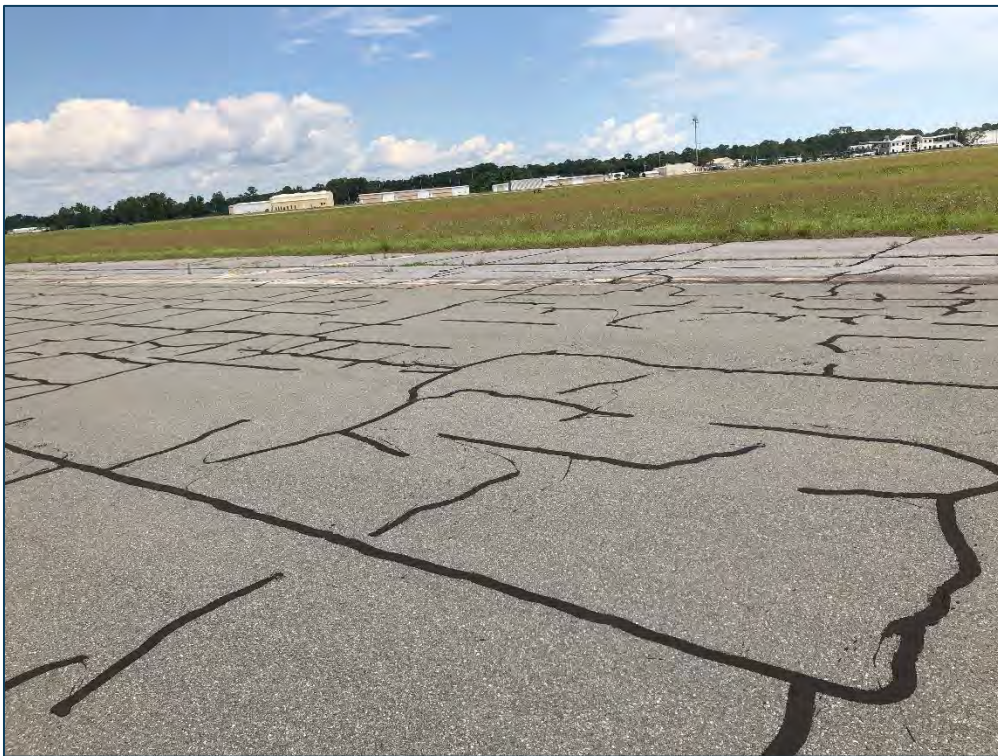
RW 13-31, Section 6215, Sample Unit 365 - Low Severity (43) Block Cracking, Low Severity (48) Longitudinal & Transverse Cracking, and Low Severity (57) Weathering

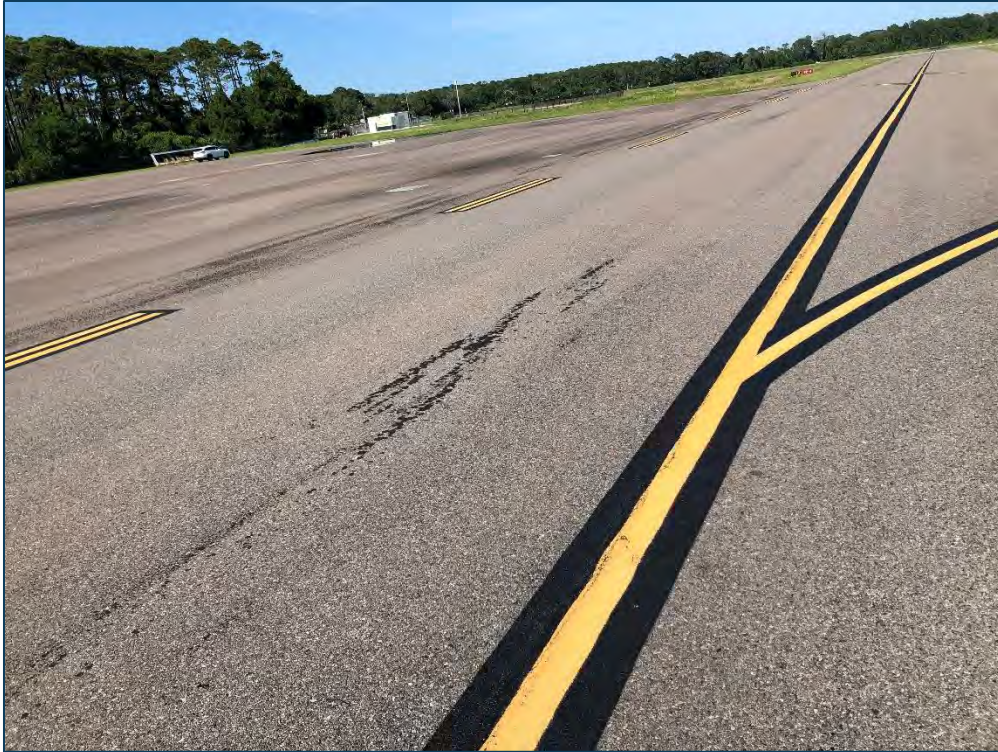
TW A, Section 325, Sample Unit 125 - (42) Bleeding Low Severity (57) Weathering

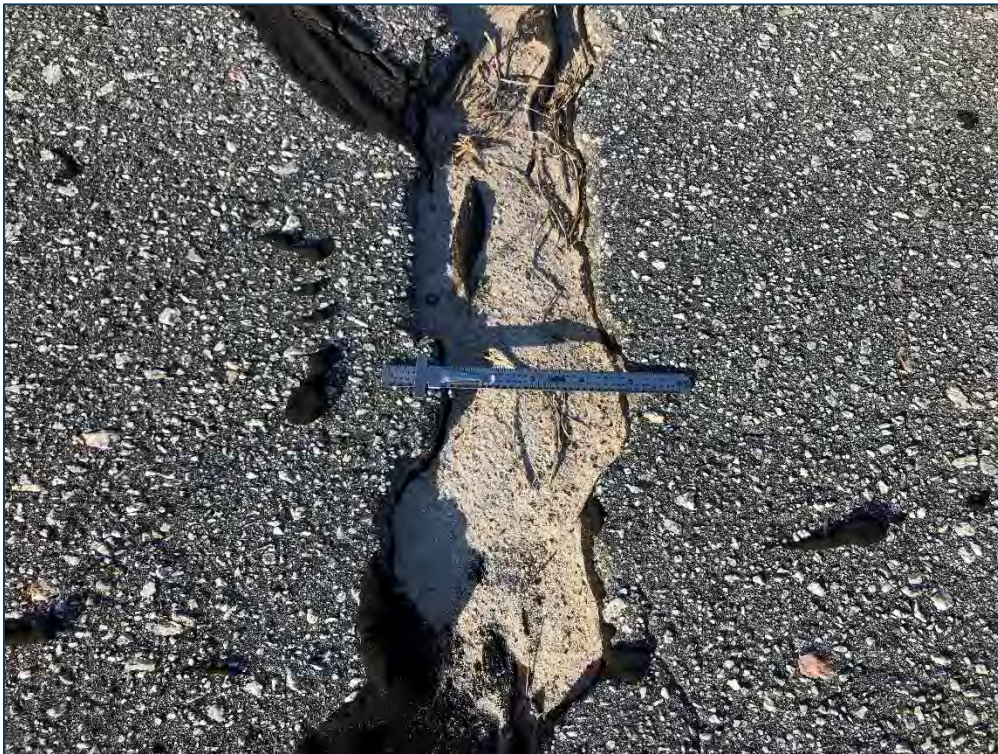
TW B, Section 230, Sample Unit 141 – High Severity (48) Longitudinal & Transverse Cracking, Low Severity (52) Raveling, and Low Severity (57) Weathering

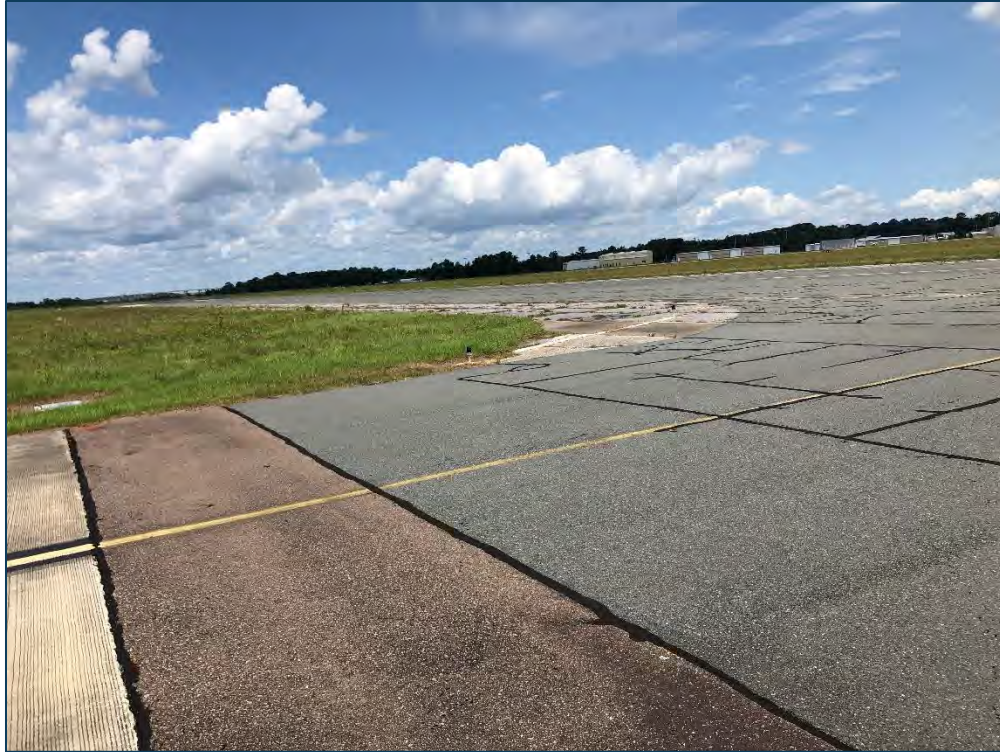
TW C, Section 120, Sample Unit 116 - Low Severity (48) Longitudinal & Transverse Cracking, Low Severity (50) Patching, and Low Severity (57) Weathering

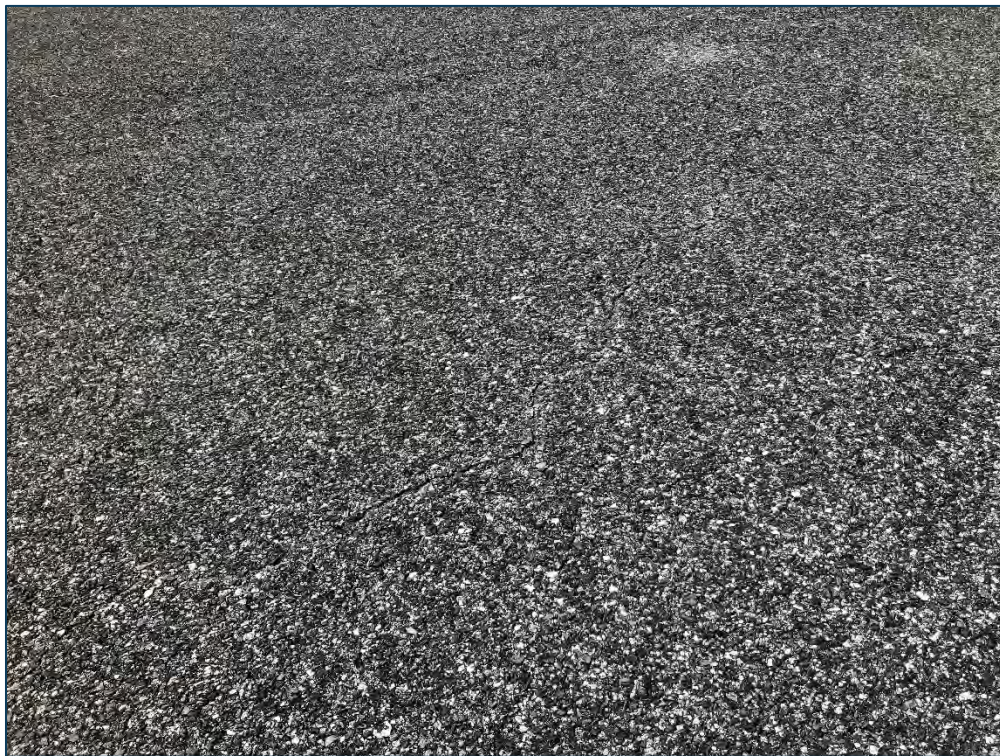
AP N, Section 4215, Sample Unit 208 - Low Severity (48) Longitudinal & Transverse Cracking, Low and Medium Severity (57) Weathering

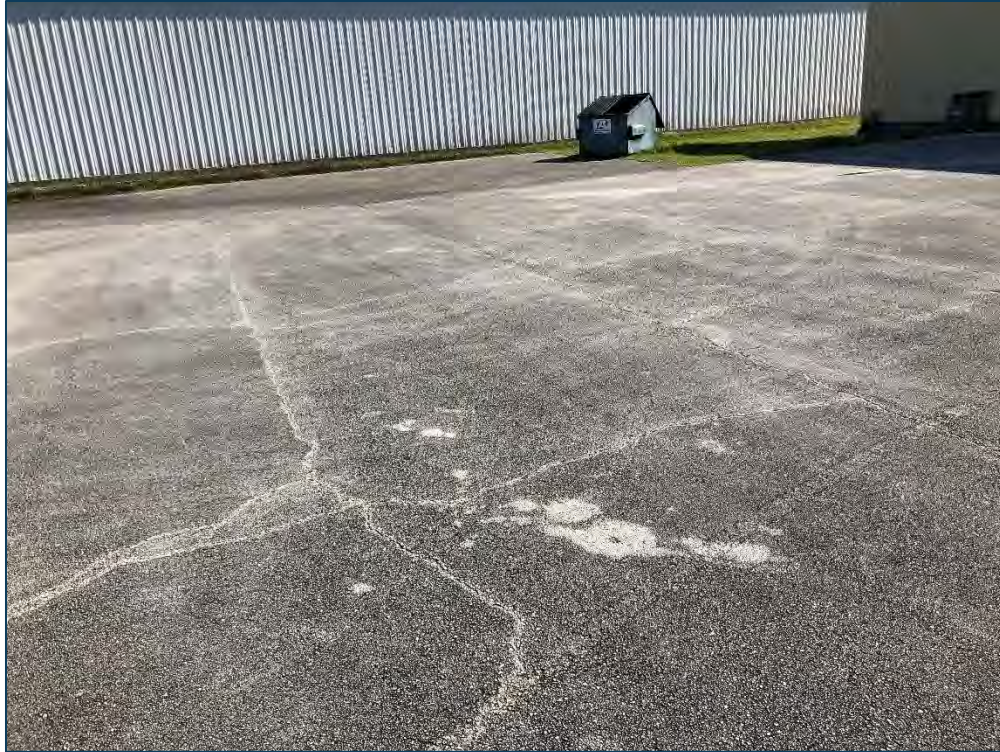
AP NW, Section 4110, Sample Unit 300 - Low Severity and Medium Severity (43) Block Cracking, Low Severity (52) Raveling, and Low Severity (57) Weathering
