**AGENDA  
BOARD OF ADJUSTMENT  
REGULAR MEETING  
SEPTEMBER 15, 2021  
5:00 PM  
CITY HALL COMMISSION CHAMBERS  
204 ASH STREET  
FERNANDINA BEACH, FL 32034**

**MINUTES  
BOARD OF ADJUSTMENT  
REGULAR MEETING  
AUGUST 18, 2021**

**RE:** **Waterfront Stabilization Analysis and Building Condition Assessment of Brett's Waterway Café – Amelia Riverfront Resiliency Study**

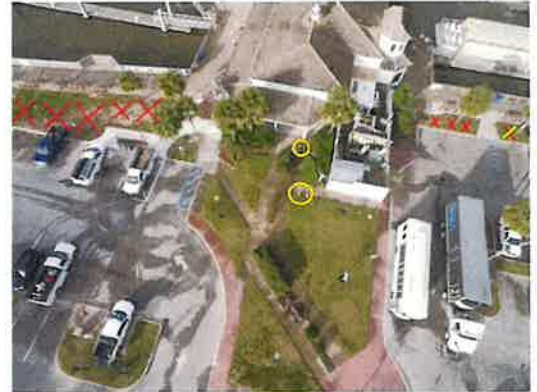
On the following page, images 0250 and 0251 show the voids found underneath the sidewalks when removed, prompting concerns about the bulkhead performance beneath the restaurant.

*\*Above Site Voids (January 2020)*

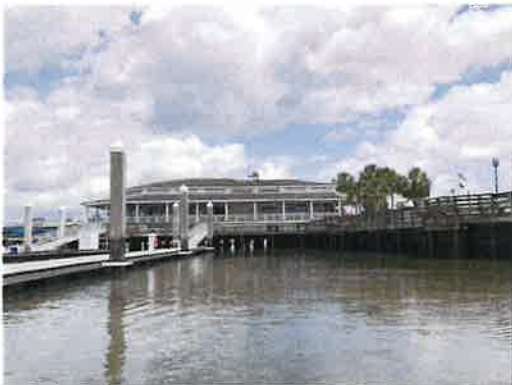
*\*Above Brett's Waterway Cafe (May 2020)*

Deterioration across all aspects of structural elements mentioned above, in previous assessments over the course of over 20 years, appeared to be ongoing with elements at various stages of deterioration or failure. Previously made repairs appear to have failed and now conceal areas of internal corrosion and deterioration. The existing concrete bulkhead appears to be shifting, causing consolidation of soil around the superstructure and pilings behind the wall. While this structure is not reliant on the bulkhead for structural stability, its failure could cause collateral damage to the existing substructure and associated deep foundations, as well as further consolidation of soils behind the bulkhead and subsequent settling of the building (left). See pictures in Appendix A, attached.

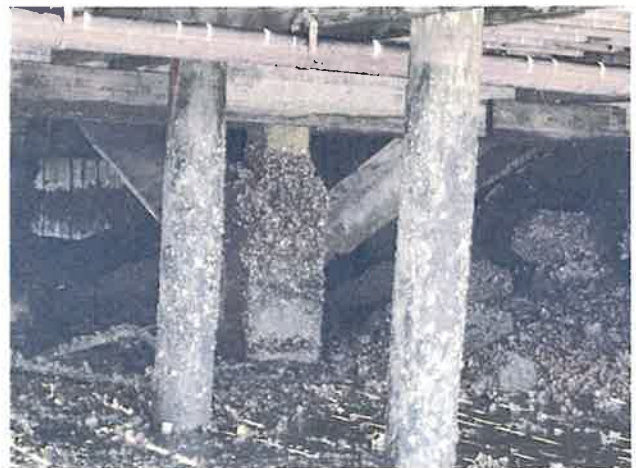
**June 2020:** Passero Associates performed a follow-up structural observation and discovered an existing double-tee member of the bottom-most substructure had failed and fallen into the river. It was unclear if this failure caused collateral damage to the existing pile cap, concrete beams, and/or superstructure above. Failure of other double-tee members is likely and could cause further damage to the overall structural foundation. See pictures in Appendix C, attached.

*\*Above Collapsed Double-T: Below Brett's Waterway Cafe (June 2020)*

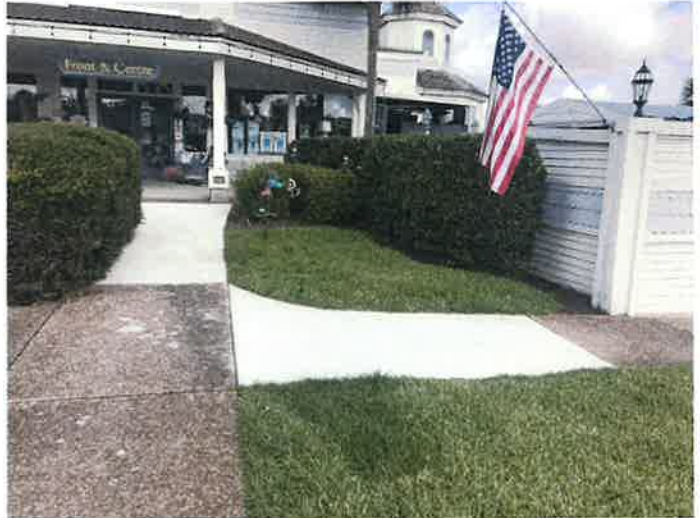
*\*Above Photo 2367 Repaired Sidewalks After Filling in Voids (January 2020)*

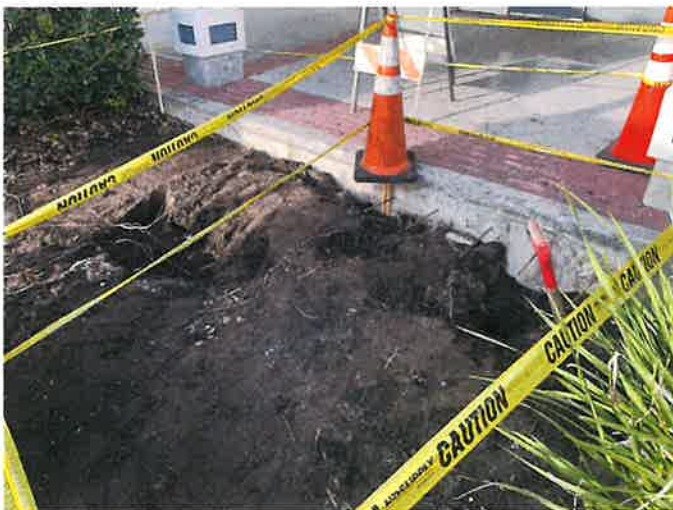
*\*Above Photo 0250 Void Found Underneath Sidewalk (January 2020)*

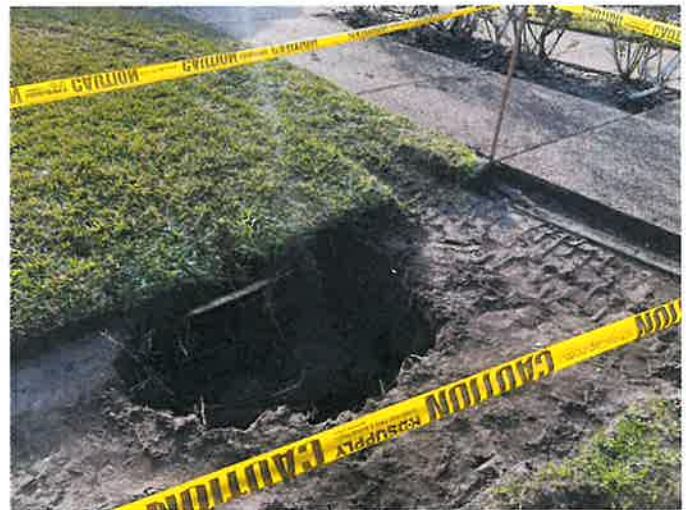
*\*Above Photo 0251 Void Found Underneath Sidewalk (January 2020)*

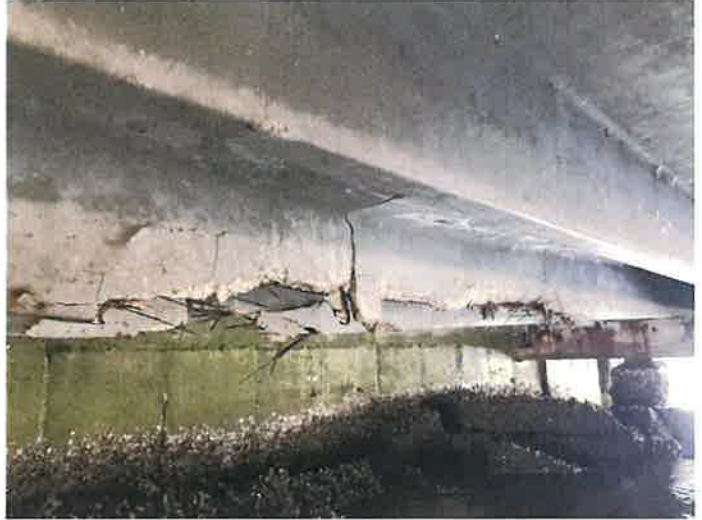
*\*Above Photo 2654 Deteriorated Double T Showing Severe Deflection (May 2020)*

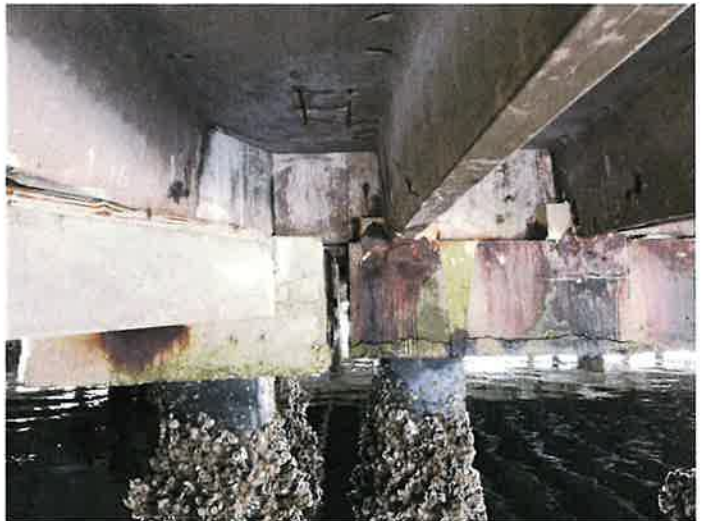
*\*Above Photo 2799 Deterioration of Metal Plates and Concrete Cap (May 2020)*

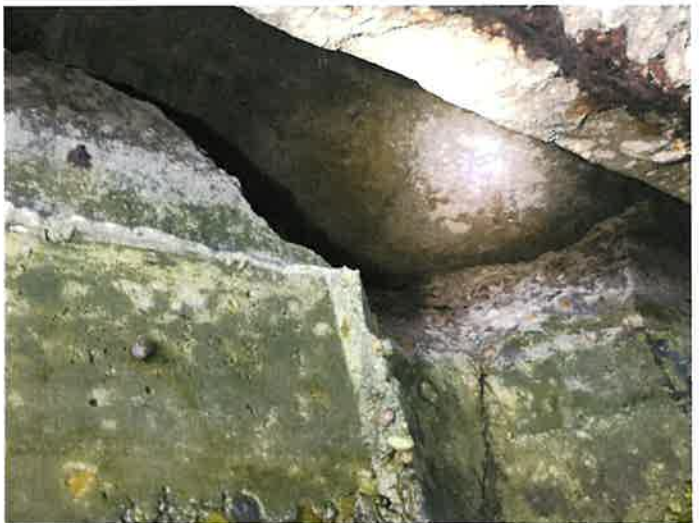
*\*Above Photo 2894 Water Droplets on Concrete Deck  
(May 2020)*

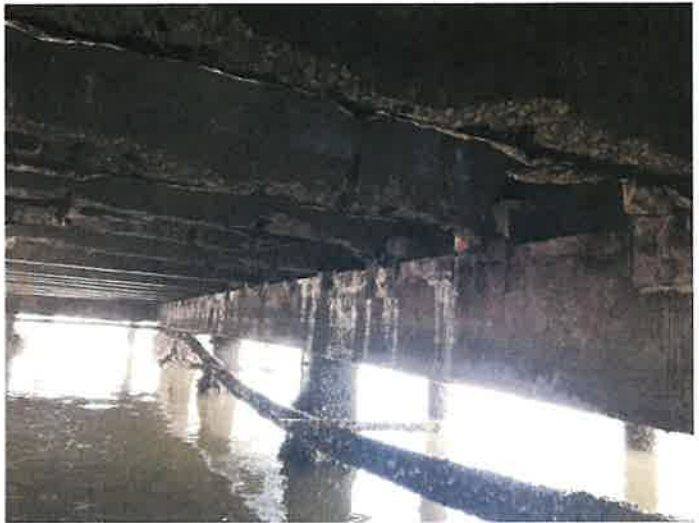
*\*Above Photo 2569 Hose Supports Have Deteriorated  
and Starting to Fail (May 2020)*

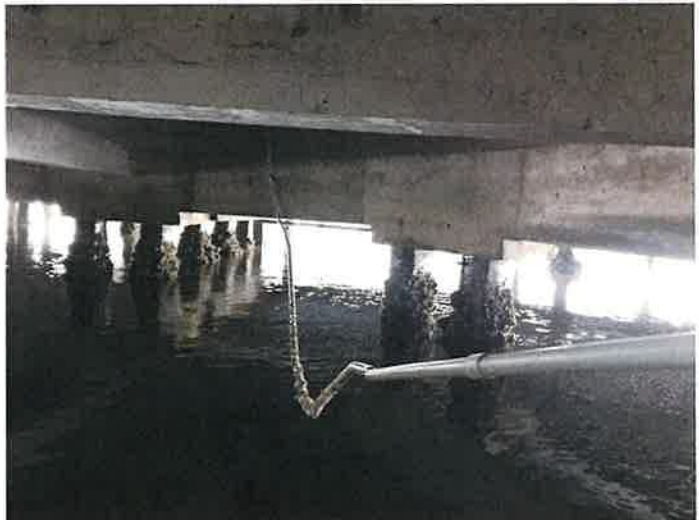
- Uncapped pipes penetrating through concrete slab and cap (Photo 2616)
- Unsupported and broken PVC conduits (Photos 2619, 2637)
- Reinforce concrete slab spalling exposing rebar (Photos 2621, 2628, 3267)
- Cracks in previous concrete beam repairs (Photos 2622, 2624, 2633, 2640, 2642, 2794)
- Cracks in concrete cap (Photo 2633)

*\*Above Photo 2619 Unsupported and Broken PVC Conduit  
(May 2020)*

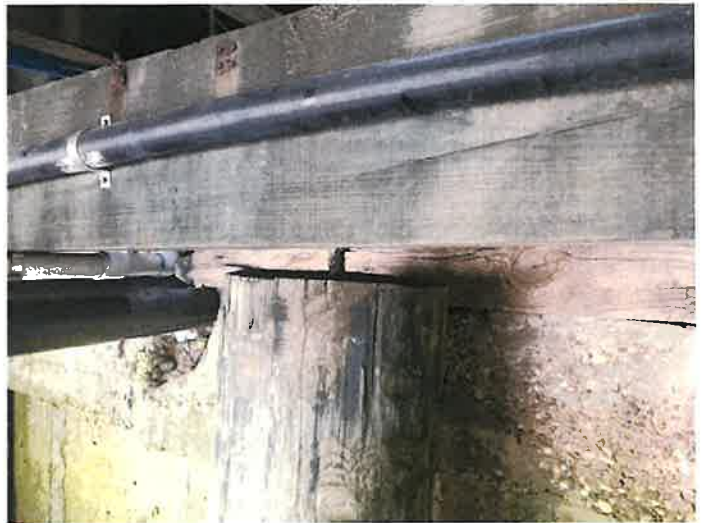
*\*Above Photo 2448 Timber Pier and Beam Separating,  
No Tie-Down (May 2020)*

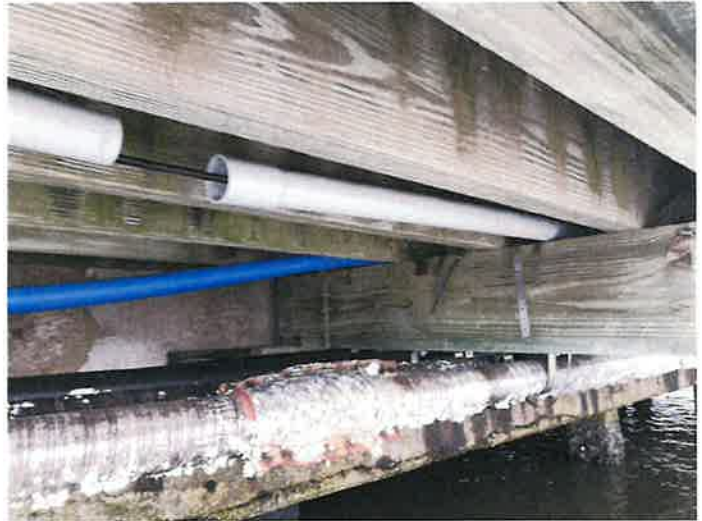
*\*Above Photo 2515 PVC Conduit Separated Exposing  
Wire (May 2020)*

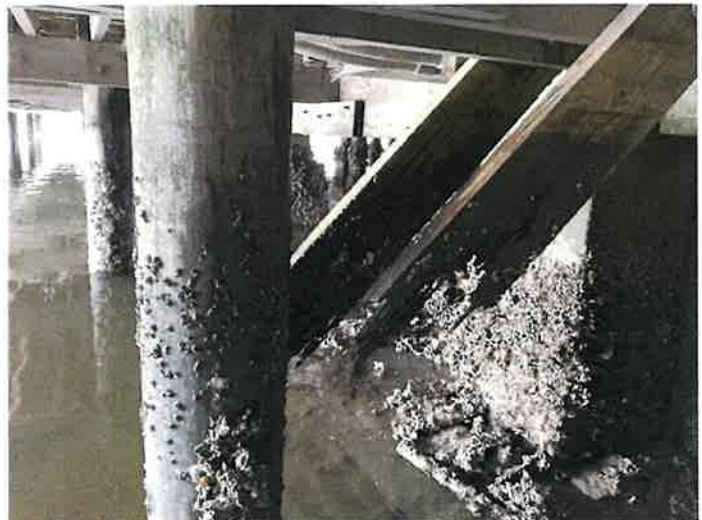
*\*Above Photo 2995 Rotted Timber Cross Bracing  
(May 2020)*

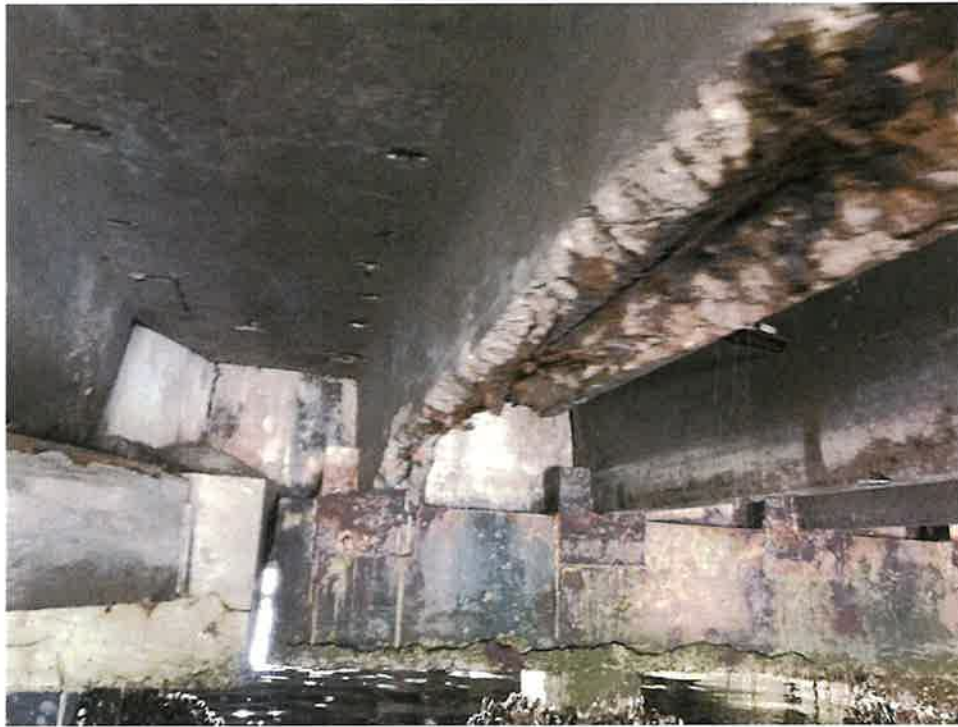
Photo 2645

- Exposed prestressing strands of the double tees, cracked concrete beam, and water leaking (Photos 2645, 2648)

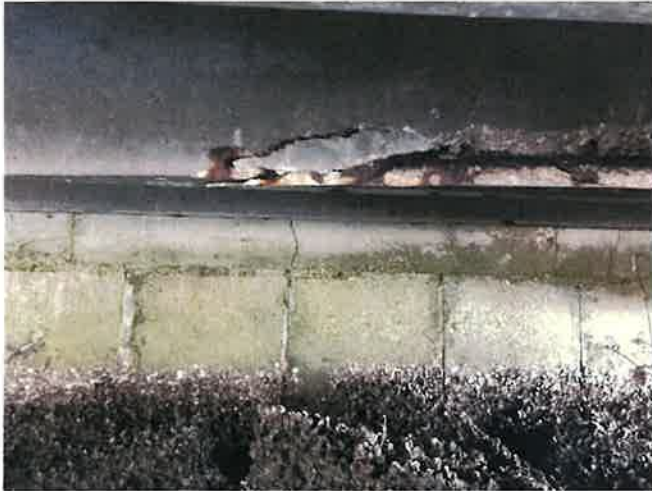
*Photo 2680*

- Cracks in concrete bulkhead cap (Photos 2680, 2685, 3322)

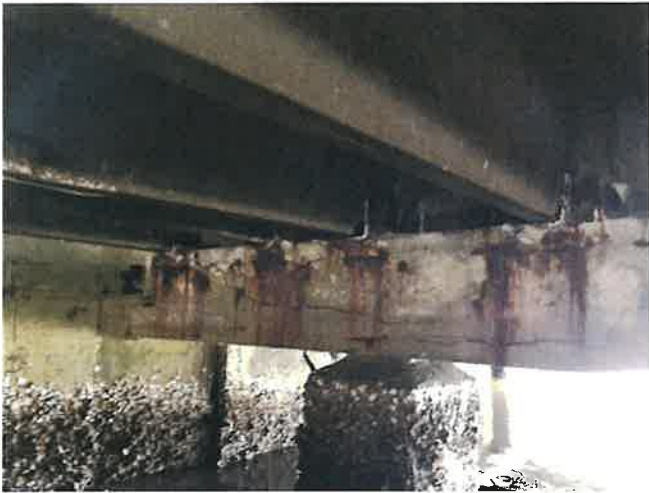
Photo 2682

- Showing severe spalling of concrete beam (Photos 2682, 2684, 2686, 3320, 3324)

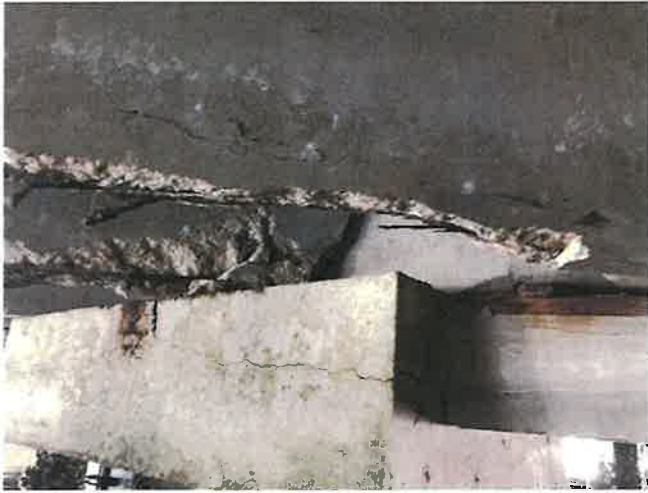
Photo 2703

- Exposed, corroding prestressing strands of the double tees and cracked concrete cap, and deteriorating metal plates (Photos 2703, 2704, 2732, 2734, 2735, 2736)

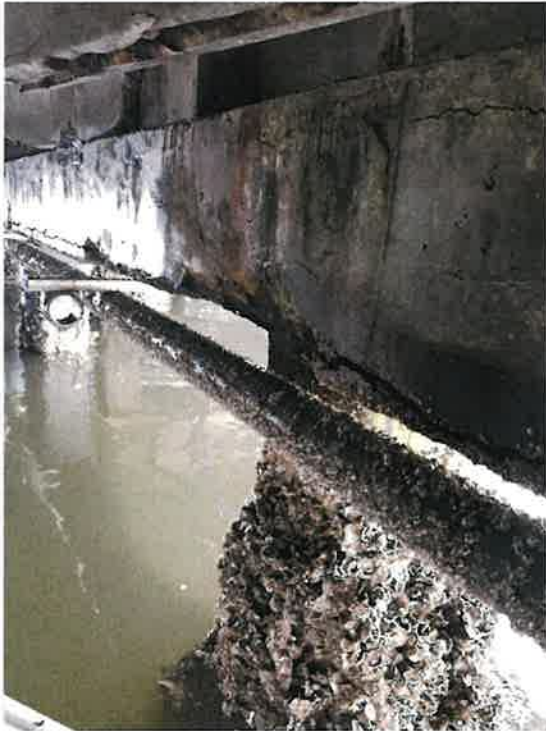
Photo 2755

- Exposed, corroding prestressing strands of the double tees and cracked/chipped concrete beam (Photos 2755, 2756)
- Uncapped PVC pipe penetrating through double tee above (Photo 3359)

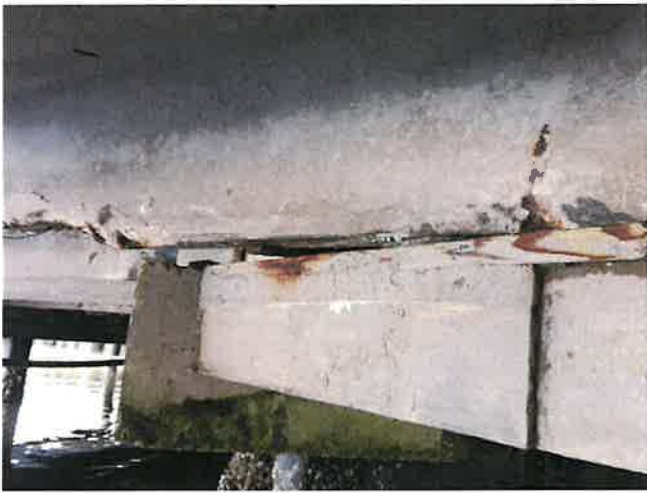
Photo 2796

- It appears that wood form boards were not removed after repair of concrete beam. (Photo 2796)
- Cracks in concrete beam and deteriorating metal plates (Photos 2799, 2804, 2831)

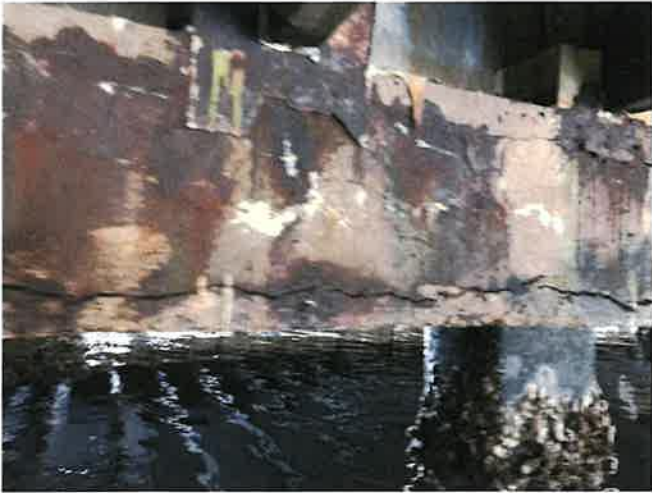
Photo 2605

- Cracks in concrete beam and deteriorating metal plates (Photos 2605, 2607, 2852, 2912, 3238, 3241)

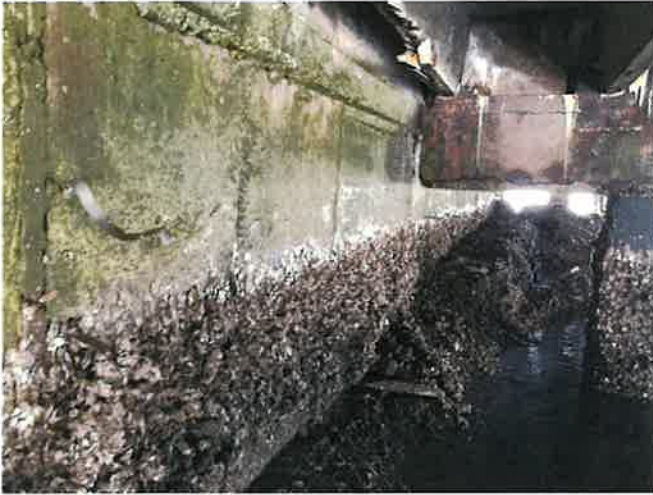
*Photo 2906*

- Cracks in concrete beam (Photos 2905, 2906, 2911)

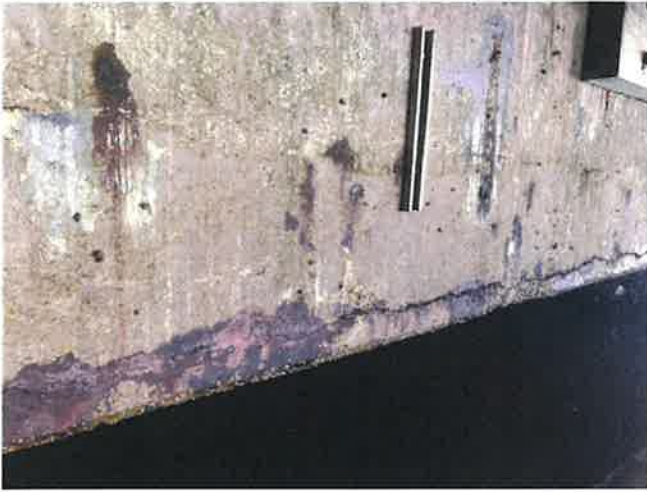
Photo 2454

- Cracks in concrete beam (Photos 2454, 2456, 2459, 2500, 3219)

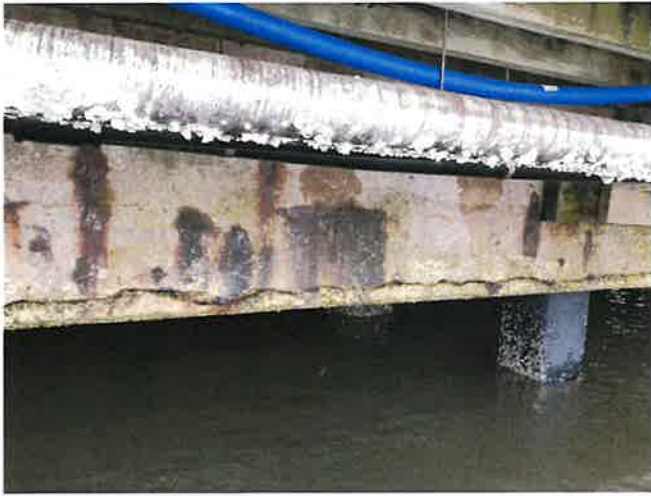
Photo 2513

- Cracks in concrete beam (Photos 2513, 2514, 2518, 2520, 2529)
- PVC pipe separating exposing wire (Photo 2515)
