**AGENDA  
AIRPORT ADVISORY COMMISSION  
REGULAR MEETING  
DECEMBER 13, 2018  
6:00 PM  
CITY HALL COMMISSION CHAMBERS  
204 ASH STREET  
FERNANDINA BEACH, FL 32034**

## **WILDLIFE HAZARD SITE VISIT FERNANDINA BEACH MUNICIPAL AIRPORT**

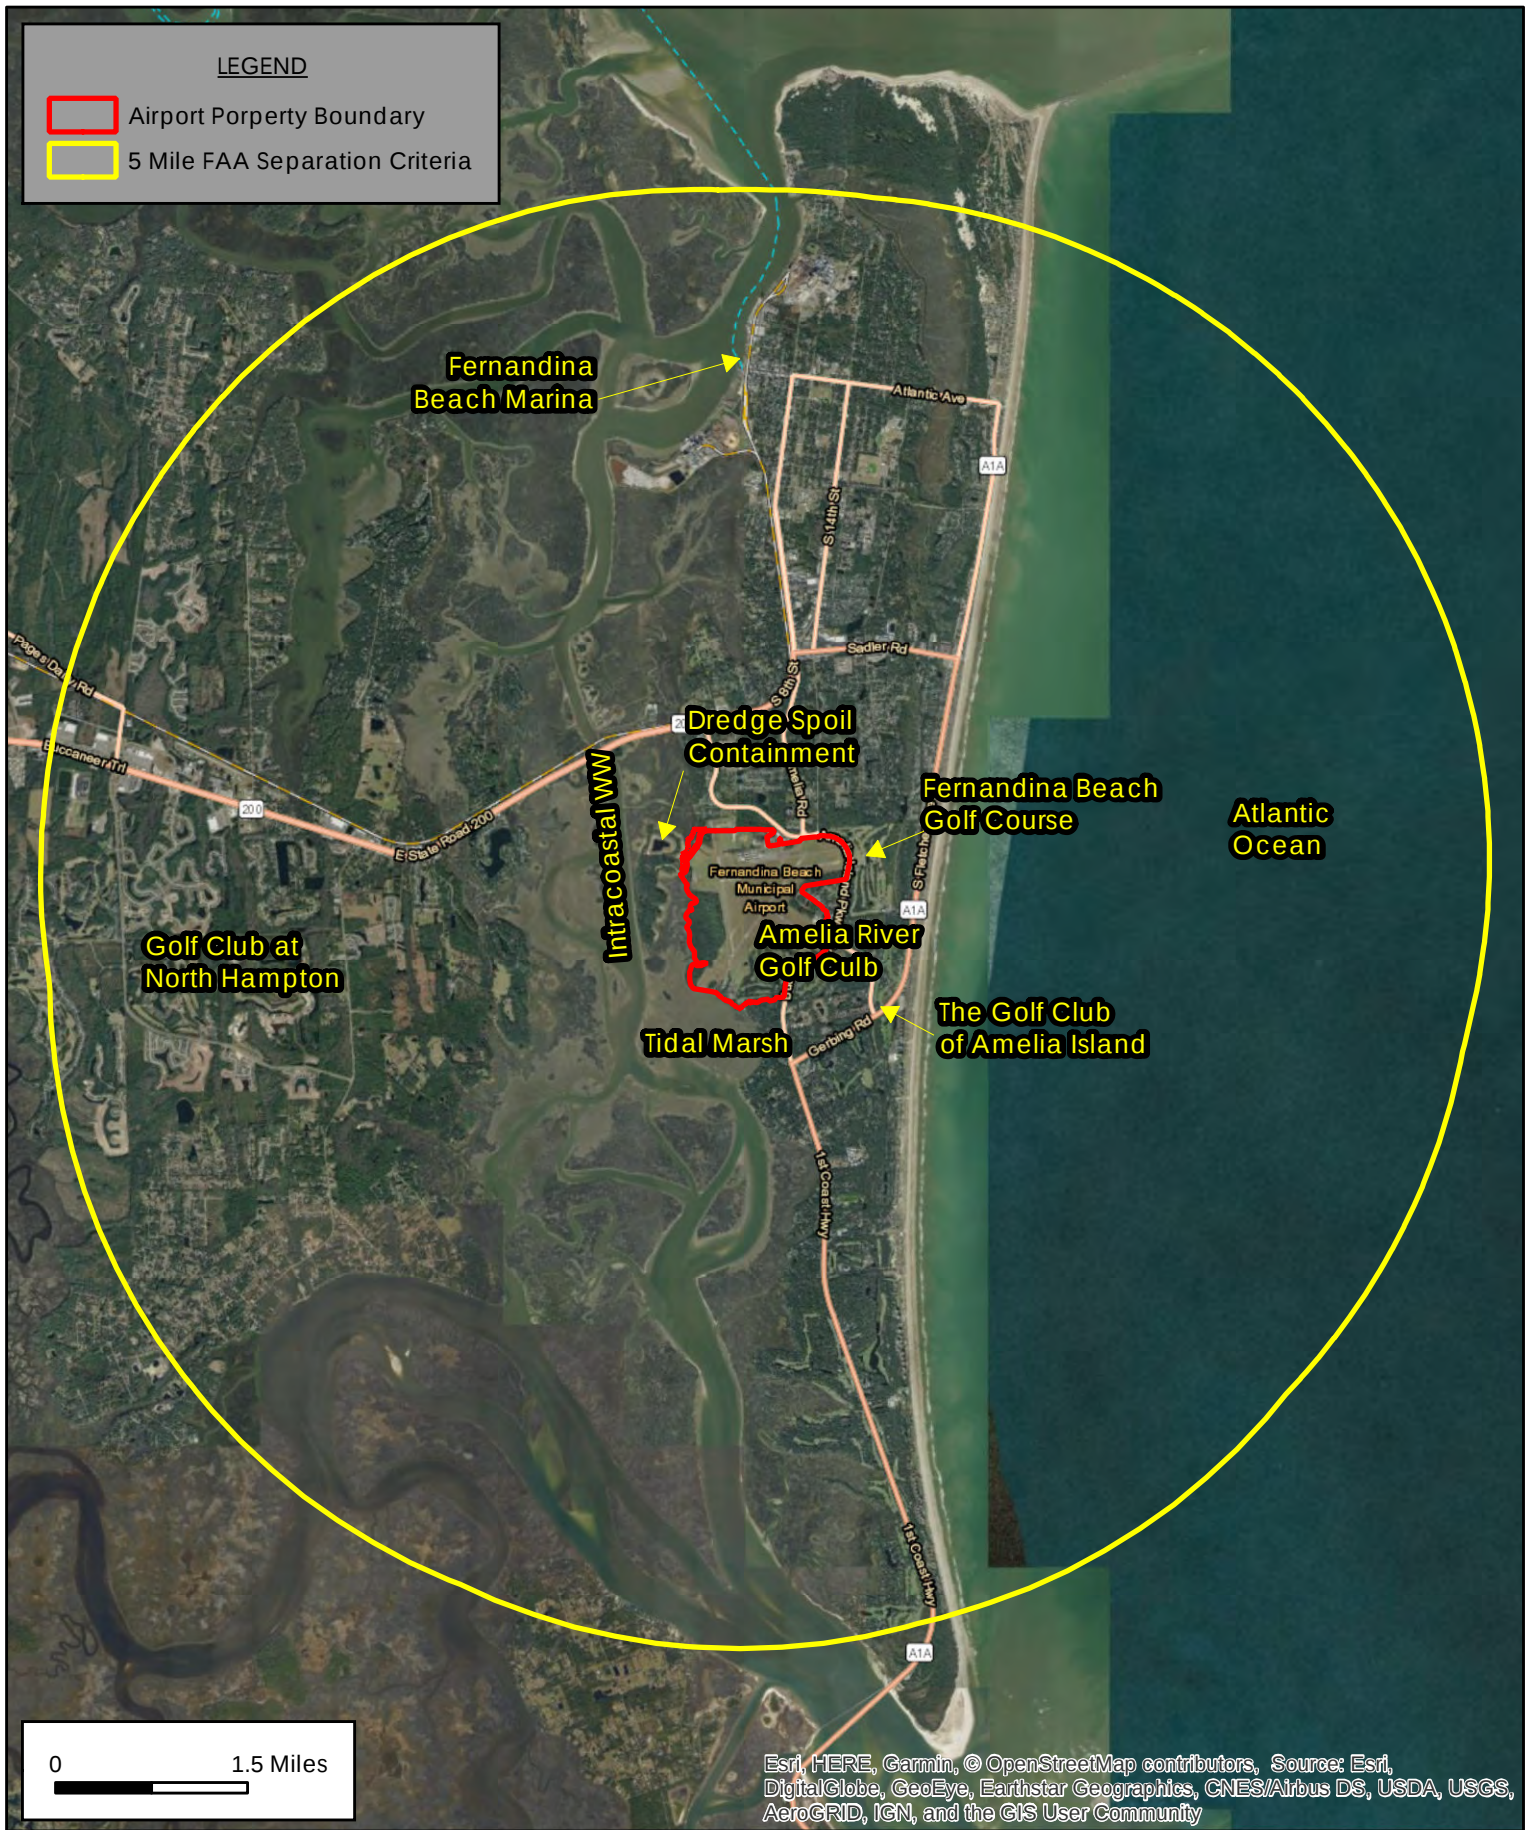
5 Mile FAA Separation Criteria

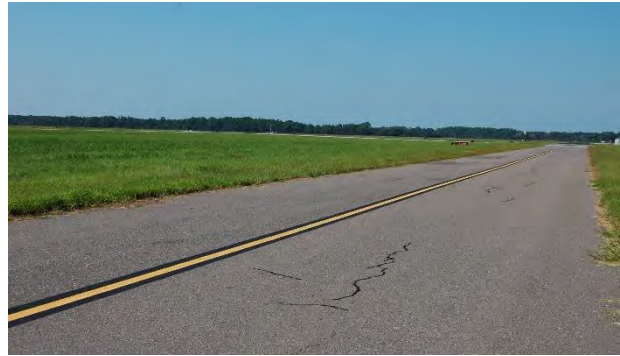
**Photo 1. FHB airfield turf looking from Taxiway A toward Runway 4/44 and the southwest.**

Airfield Turf - Various grass and weedy species comprise the airfield turf within the AOA at FHB, which is regularly maintained by mowing. Guidance on mowing heights for airfield turf is found within the FAA/USDA document titled, "Wildlife Hazard Management at Airports: A Manual for Airport Personnel" (2005). Typically, the FAA recommends a thick monoculture of grass managed between 6-12 inches. **Photo 1** provides a picture across the airfield showing the typical turf at FHB. Generally the airfield turf was healthy and well maintained. Recent rain events have limited access to low-lying areas, therefore, some maintenance is required to reduce turf heights and control broad leaved weeds. Intermediate grass height (6-12 inches) disrupts or blocks the ability of small flocking birds (such as blackbirds and doves) to visually communicate, therefore, they are less likely to flock in large numbers in these areas. In addition, a dense monoculture of grass will decrease the presence of broad leaved weeds and bare areas, which can create an attractant to birds. Fertilization and selective herbicide use could help to strengthen the existing stand of grass and reduce broad leaved weeds.

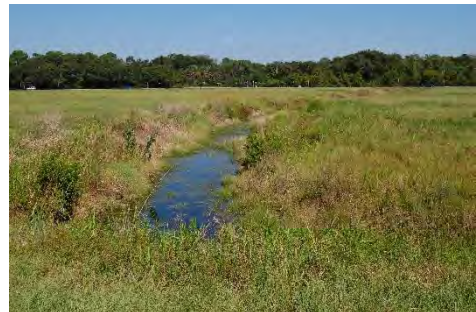
**Photo 2A. Typical drainage ditch on FHB. Maintained with limited vegetation and standing water.**

The ditches at FHB contained overgrown vegetation and standing water, but did not appear to attract wildlife (**Photos 2A and 2B**). No wildlife were observed using the ditches throughout the WSHV. There were several dry retention ponds observed on the airfield and additional ponds immediately outside of the AOA, however, no wildlife were observed using these areas during the WSHV either. Retention ponds should be maintained similar to surrounding turf.

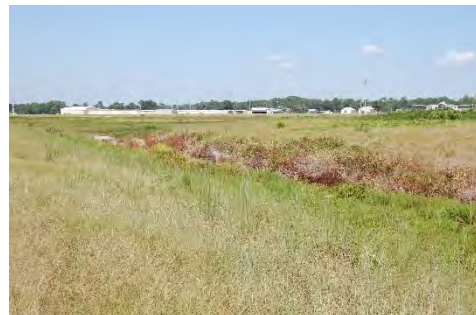
**Photo 2B. Drainage ditch on FHB. Lacking proper maintenance with ample vegetation to provide cover.**

It is possible that the abundance of available pond sites in the local area provide ample foraging opportunities, limiting the need for wildlife to use resources on the airfield. Nonetheless, improved maintenance would further reduce the likelihood of ditches attracting wildlife.

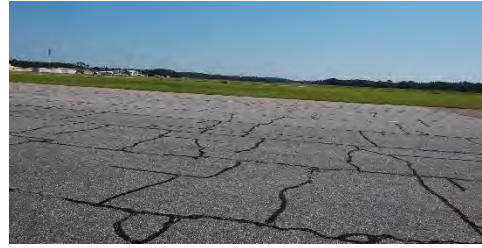
**Photo 3. Abandoned runway with deteriorating surface.**

Bare Areas - Bare areas of concern may include abandoned or poorly maintained hard surfaces or turf with exposed soil. At FHB, bare areas were limited, however, the abandoned runway on the west side of the AOA was an exception (**Photo 3**). These areas can provide ideal nesting habitat for killdeer and attract doves/pigeons that must ingest grit to aid in digestion. Hard surface areas can be swept to minimize available grit and adhesives may be used to reduce future deterioration. The area is currently being maintained with crack sealant which can reduce availability of grit. Bare patches in turf are minimized through proper mowing and fertilization, if needed. Maintaining an intermediate grass height (6-12 inches) throughout the AOA and reducing mowing where it may be too wet are common strategies to avoid bare areas in the turf.

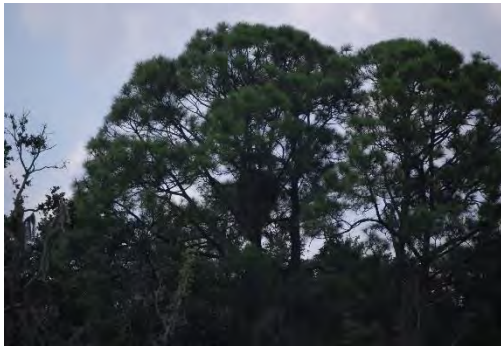
**Photo 6. Bald eagle nest location. Last known active 2013.**

lesser yellowlegs, and killdeer), and waterfowl (e.g. blue-winged teal). There is also a bald eagle nest located adjacent to the FIND site. The nest was last surveyed and last known active in 2013 (**Photo 6**). This is notable as FHB does not currently possess a BGEPA Depredation Permit from the USFWS.

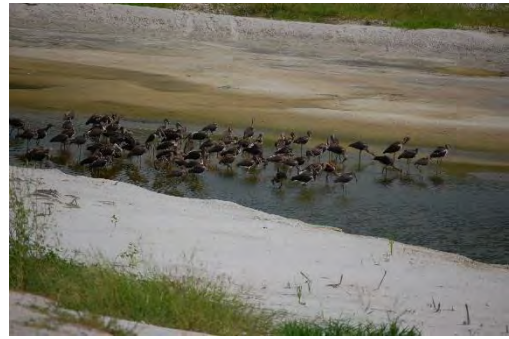
**Photo 5. White ibis foraging in ponded water at FIND dredge spoil site.**

Most notably there is a dredge spoil containment area which is owned by the FIND and is used to hold dredge spoil from the Intracoastal Waterway. This site is routinely used to hold dredge spoil material until a suitable location is found for its disposal. At the time of the WHSV there was little dredge spoil in the containment area, however there was a depressional area with ponded water which attracted wading birds (e.g. white

ibis, **Photo 5**), shorebirds (e.g. western sandpipers,

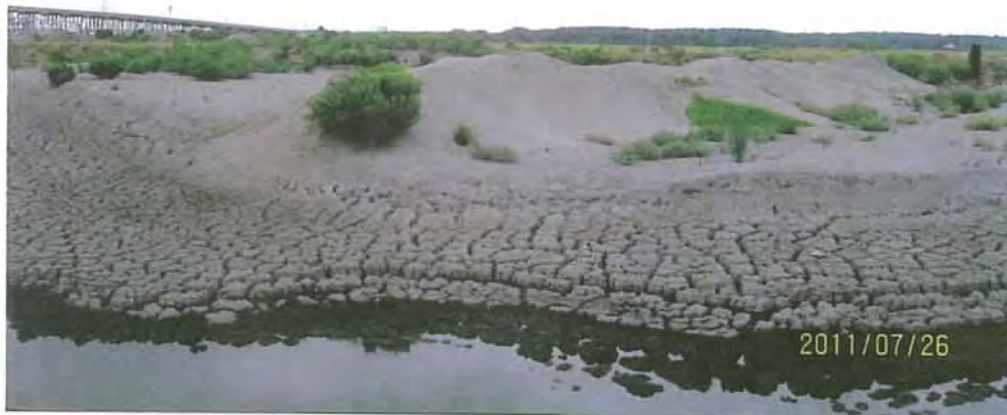
1) View of the existing dredge spoils material pile located near FHB (July 26, 2011).

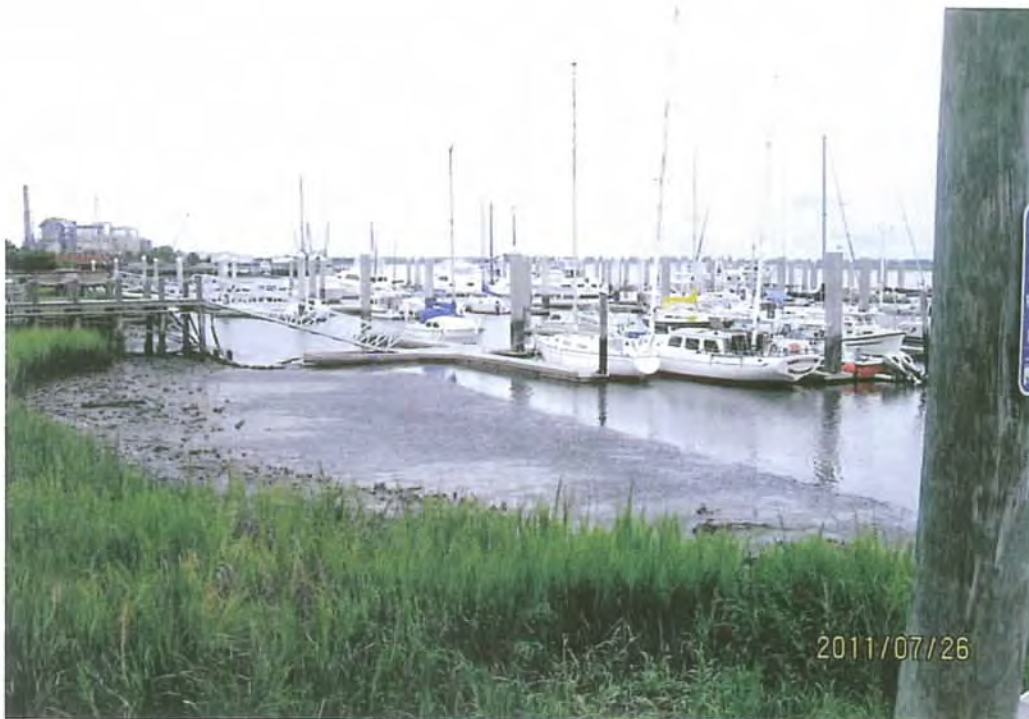
2) View of the marina that will be dredged (July 26, 2011).

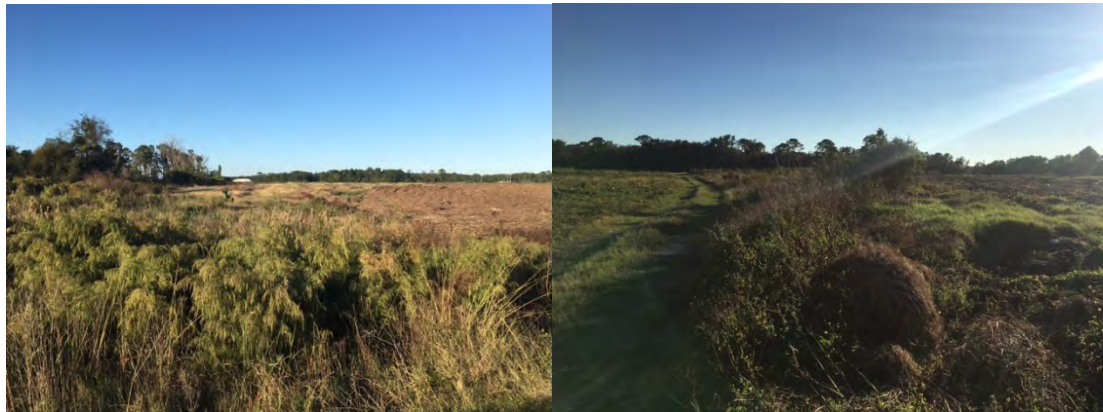
### 2012 Dredge Spoil Placement Site (Airport Property)

2. In 2012, dredge spoils from the same location, and of similar composition, were placed on the airport. As demonstrated in the photos below, turf and vegetation has regrown in this area over the past few years. The material placed in 2012 is similar in composition to the material proposed for placement now, and the same outcome is expected. In review of the placement process in 2012, sand was not mixed with the dredge material prior to placement.
