**AGENDA**  
**FERNANDINA BEACH CITY COMMISSION**  
**WORKSHOP**  
**SEPTEMBER 21, 2021**  
**4:00 PM**  
**CITY HALL COMMISSION CHAMBERS**  
**204 ASH STREET**  
**FERNANDINA BEACH, FL 32034**

SUBJECT: Discussion - City Hall

SYNOPSIS: This item is placed on the agenda at the request of Commissioner Ross. Discuss City Hall renovation and/or, rehabilitation and/or, relocation.

## Assessment of Existing Building and Site Conditions

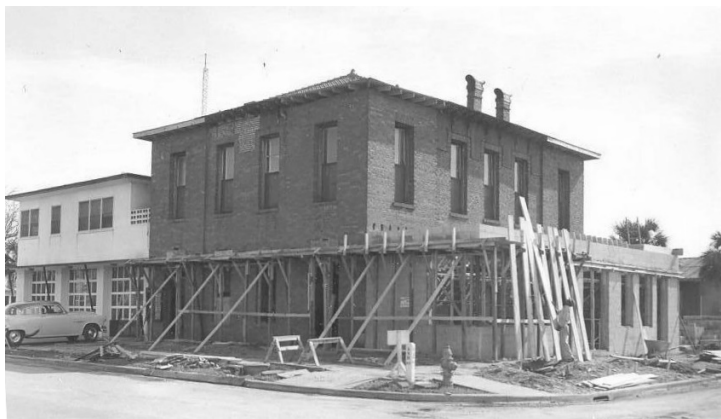
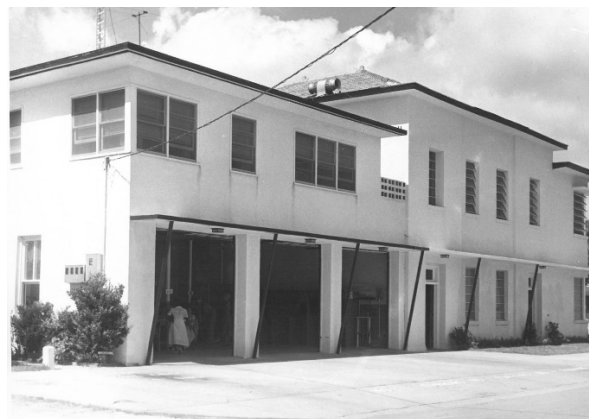
Through the 1950's, several phases of renovation began to significantly alter the architectural character of the City Hall. A second story was added above the fire department bays and the brick veneer of the modified east wing was covered in stucco. Later, the main two-story element was severely altered, removing the towers and vertical parapets and chimney stacks and replacing the historic tile roofing. Over time, a two-story addition was added to the west façade along S. 2<sup>nd</sup> Street and the remainder of the historic brick was covered in stucco. During the alterations of the main volume of the building, window heads were lowered substantially, taking away from the vertical proportion of the original openings.

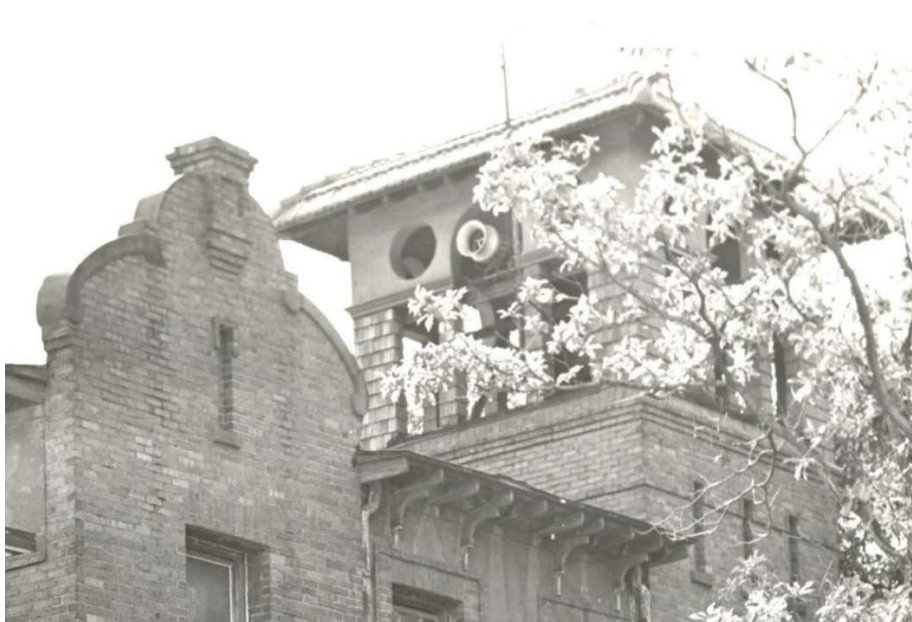
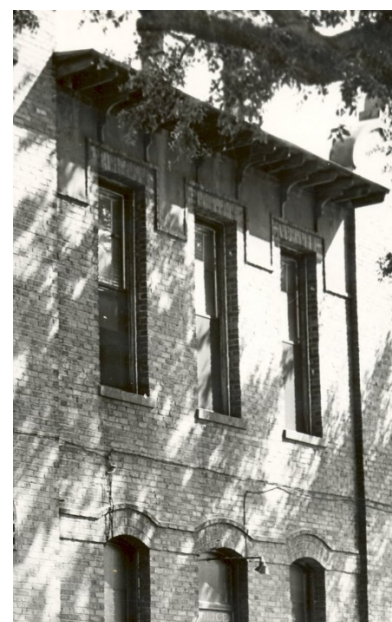
Additionally, one-story additions were constructed along the east and south façade of the original fire station portion of the building. As noted in this Assessment sections of this document, the design and construction methods of the various additions to the historic building lacked the robustness and permanence of the original construction and generally were not in keeping with the materials and systems befitting a civic building. Throughout the alterations, the **iconographic image of the original City Hall and the community's collective memory of place has been compromised.**

Due to both their building performance failures as well as the opportunity to restore the original building footprint, the Assessment Team's recommendation is that the two-story addition along S. 2<sup>nd</sup> Street, the second-floor addition above the fire station bay, and one-story additions along the east and south edges should be removed. This strategy seems more appropriate than the significant investment required to upgrade the poorly constructed additions, and will restore a semblance of the building's original massing and its relationship to the street.

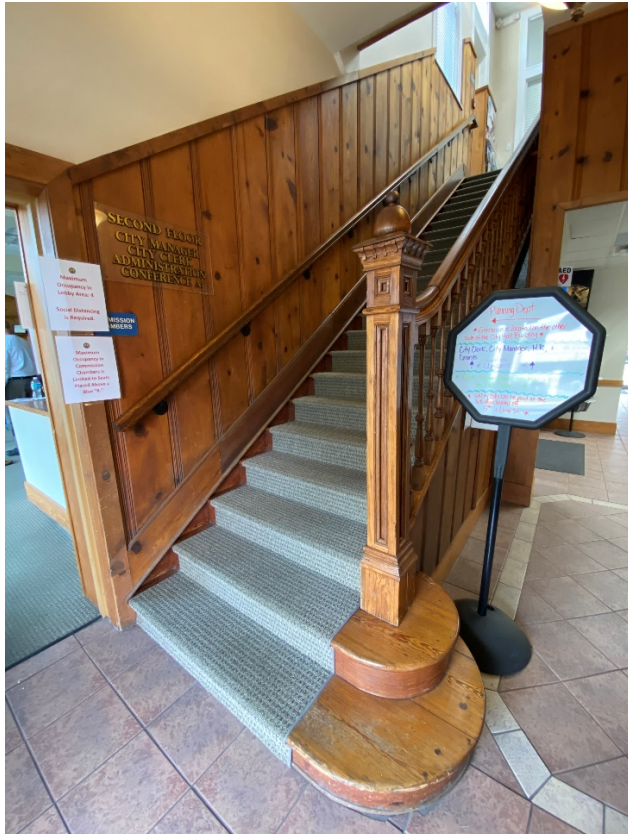
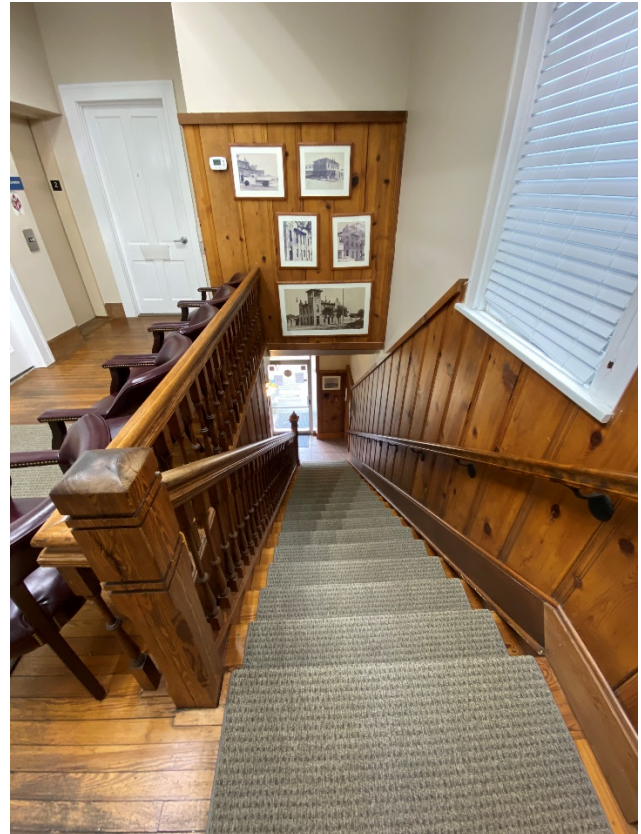
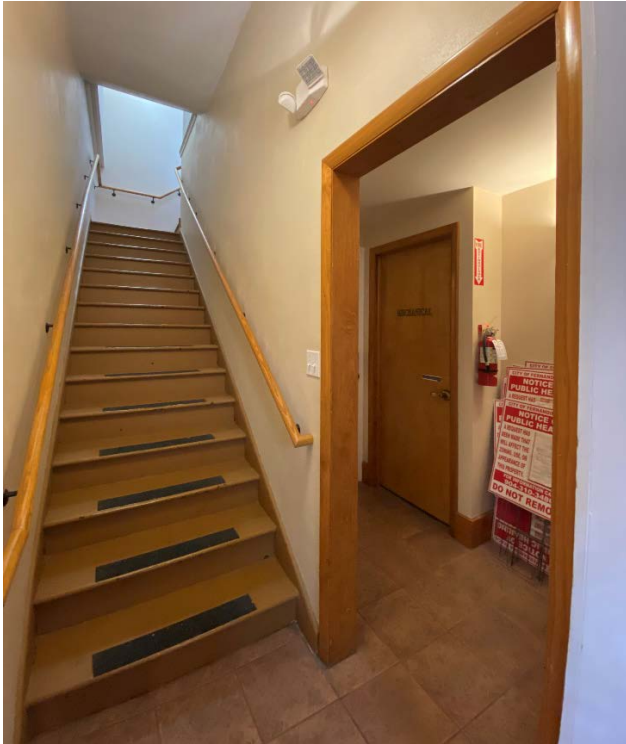
### Interior Stair Compliance Issues

**1011.3:** The existing interior stairway near the southeast corner of the building has a headroom clearance of 72 inches and is less than required by the Code.

**1011.5:** Both set of interior stairs fail to meet numerous dimensional requirements of the Code, including required tread depth and riser heights of 1011.5.2, dimensional uniformity requirements of 1011.5.4, and nosing profile and project requirements of 1011.5.5.

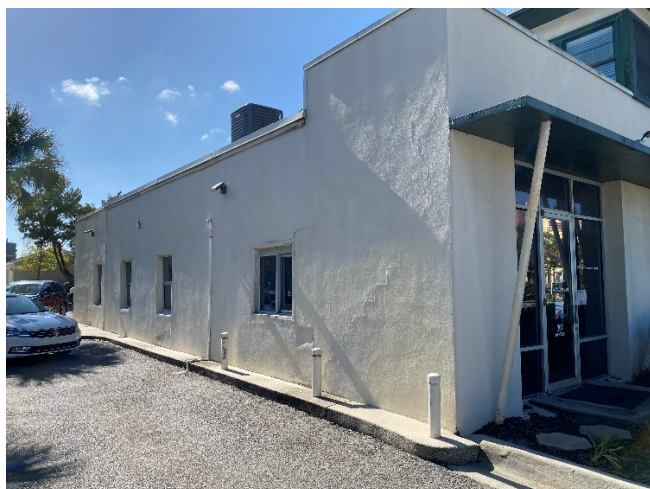
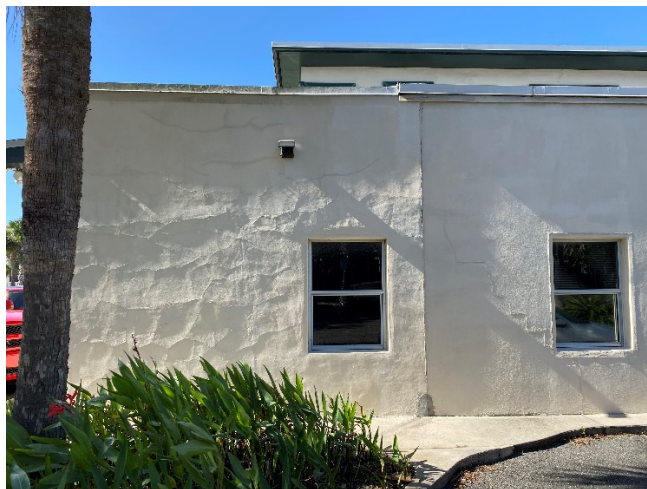
A cement-based stucco finish has been applied to the entire building. Cracking is present throughout the building envelope, with more significant cracking present at the more recent additions to the historic building. Stepped cracking of the masonry back-up is broadcasting through the stucco at the east façade, and may be evidence of differential settlement of the building foundations. The one-story addition at the south façade has a failing stucco finish indicating a severe problem in the wall construction.

Based on the condition of the architectural exterior systems, it is assumed that they would undergo significant repair and/or replacement depending on the architectural character and exterior expression of the renovated project. Further investigation is needed in study of the stucco systems, both in terms of their technical performance as well as the visual opportunities of the project as a historic preservation of City Hall.

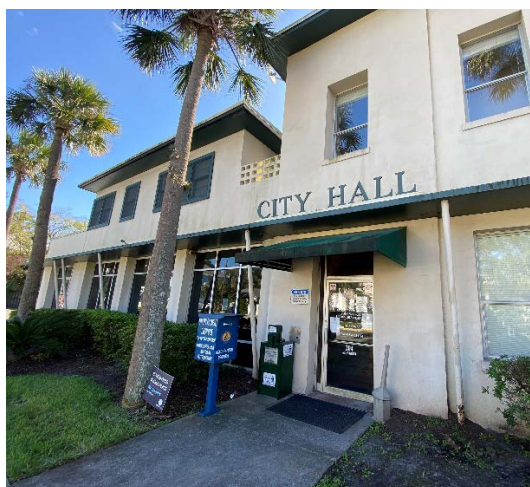
As a part of previous renovations, a cast-in-place concrete canopy with angled steel pipe column supports were added along the main façade on Ash Street and turning one bay along S 2<sup>nd</sup> Street. Rusting of the steel column bases at grade and column caps at the connection to the concrete canopy must be addressed.

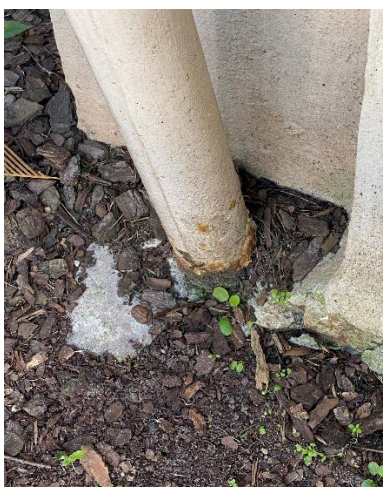
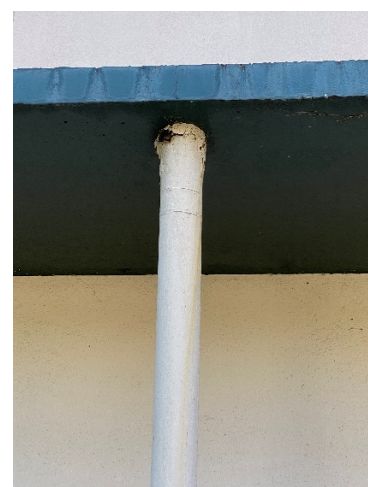
A second applied concrete projection was added above the second-floor window at the corner of S. 2<sup>nd</sup> and Ash Streets. The top surface of the concrete has not been protected with the same painted finish as the vertical face and underside and is subject to deterioration through weathering and freeze-thaw conditions.

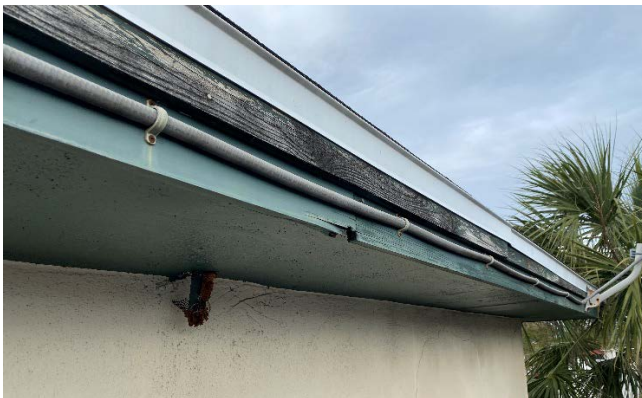
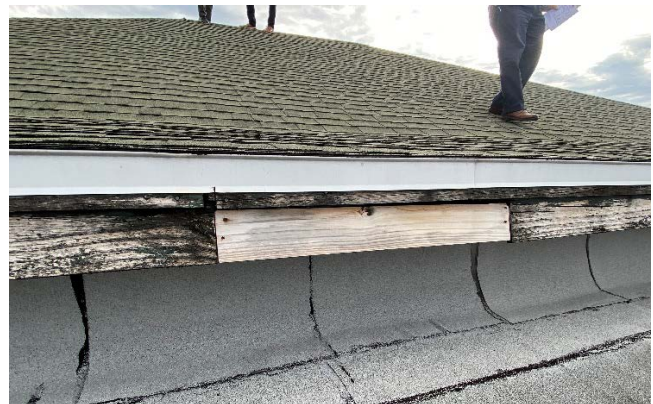
Soffits and fascia at the projected eave of the original City Hall two-story volume and the second-floor addition over the City Council chambers are constructed of cement board and/or wood panels. Painted finishes have weathered away and some members have been replaced and left unpainted. There is visible evidence of wood rot at butt joints and fascia corners.

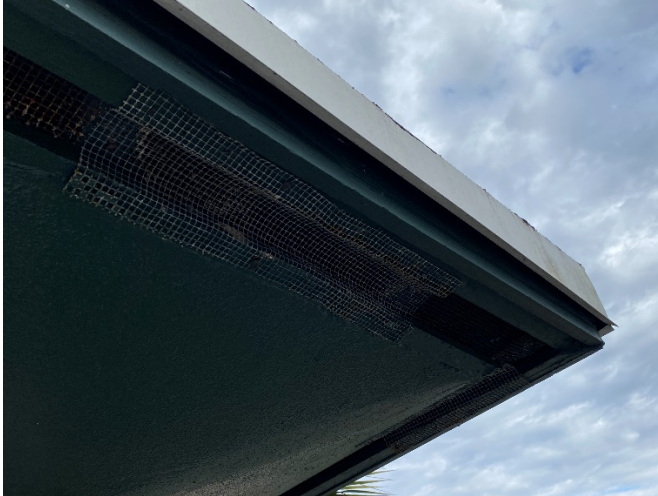
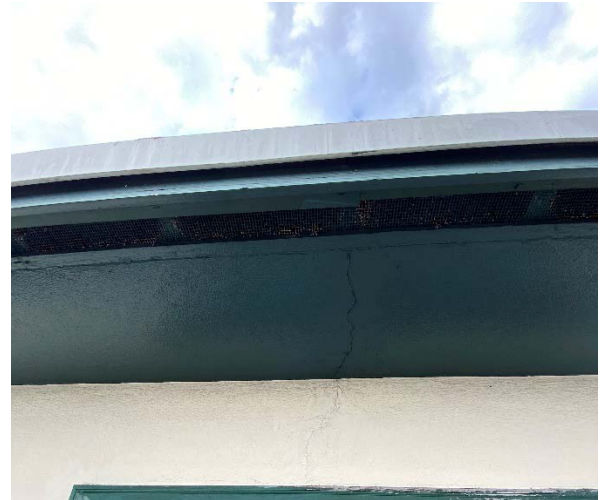
Areas of the lower roof projected eaves are vented and protective screens have failed and been replaced with surface fastened sections. Control joints are not installed in the cement board or wood soffit materials, and the thermal expansion or deflection the panels exhibit some cracking.

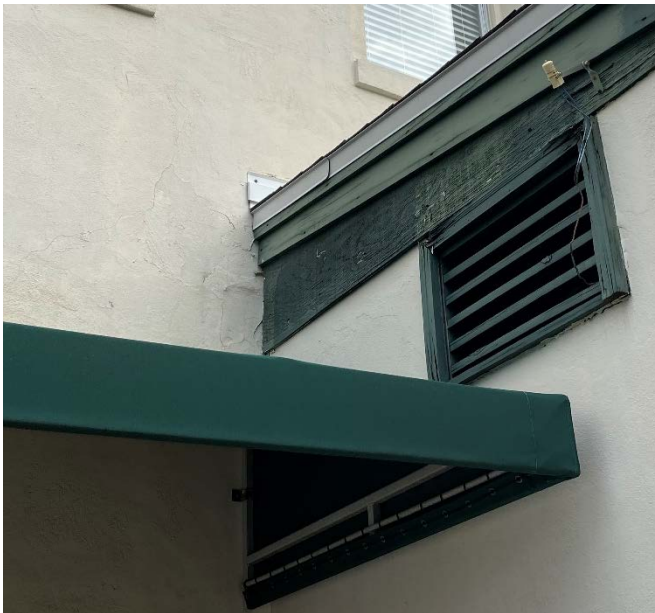
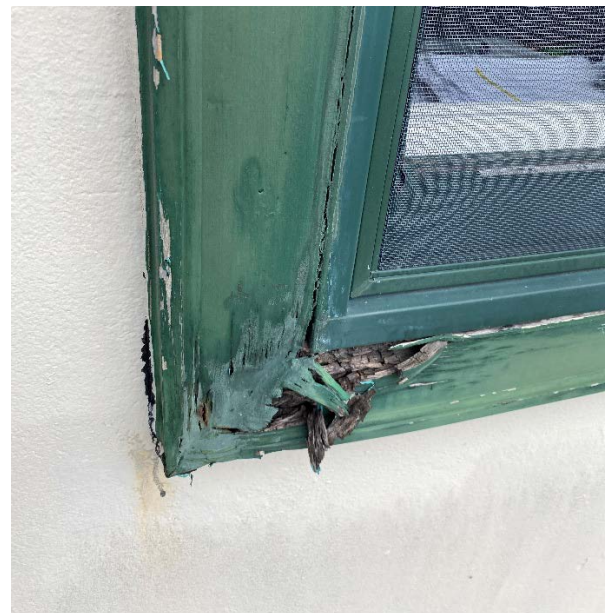
Various material transitions from fascia and roof terminations to the stucco walls are poorly flashed and lack appropriate sealants. Plywood rake trim, wooden louver frames, and applied wooden window trims have rot damage.

Exterior wood trims and sealants around window openings and roof edges are currently being addressed through repair and/or replacement. Given the likely phasing of the renovations of the historic City Hall, it is prudent to continue modest repairs to protect the integrity of the structure and its contents.

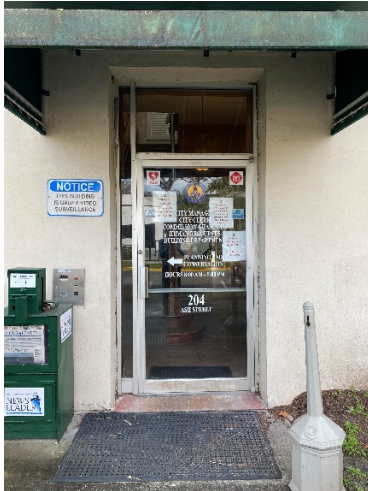
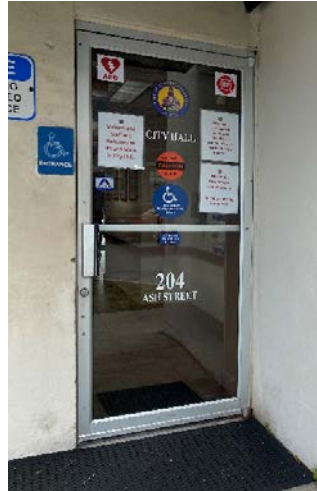
A newer aluminum storefront entrance for staff access has been added. The immediate step at the door threshold down to the adjacent walk does not comply with egress or accessibility requirements. An exposed wood header is subject to continued deterioration. The overhead closure installed on the exterior of the opening is rusting. A painted hollow metal door is installed in a painted wood frame at the primary electric service room.

Based on the condition of the architectural doors and frame, it is assumed that they would be wholistically replaced, but for the single historic window noted above. Thoughtful design and selection of new doors and windows can address performance issues as well as bring visual cohesion to the building envelope.

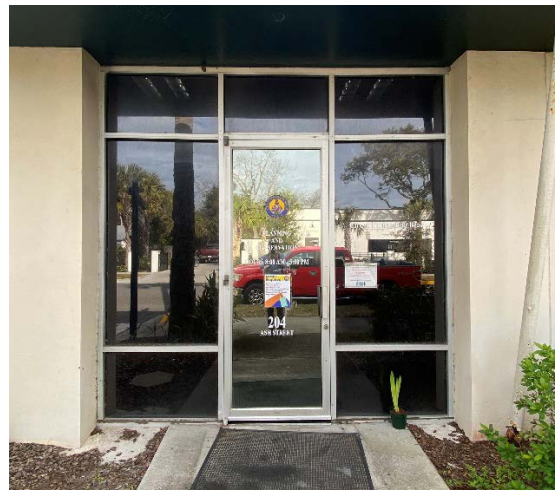
Exterior doors vary and include aluminum storefront entrance systems at the public entries on Ash Street and the rear parking lot as well as the public entrance to the Planning Department. The systems are of the narrow-style variety and are generally lighter duty than would be specified for a high-traffic, public civic facility.

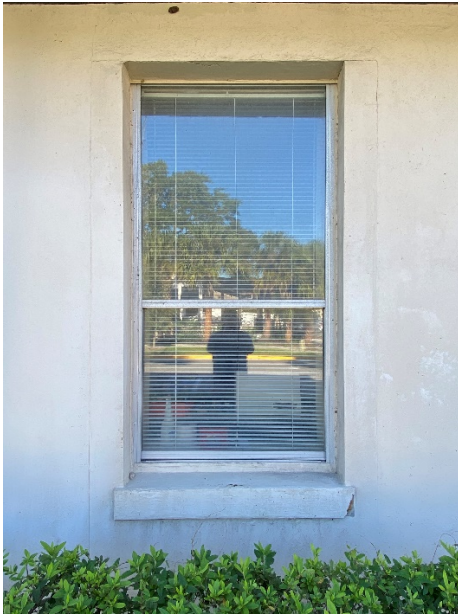
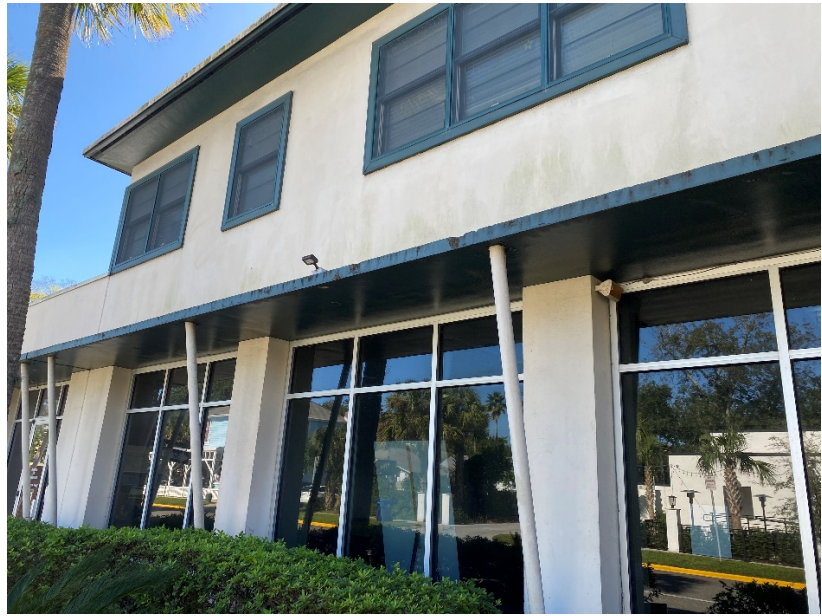
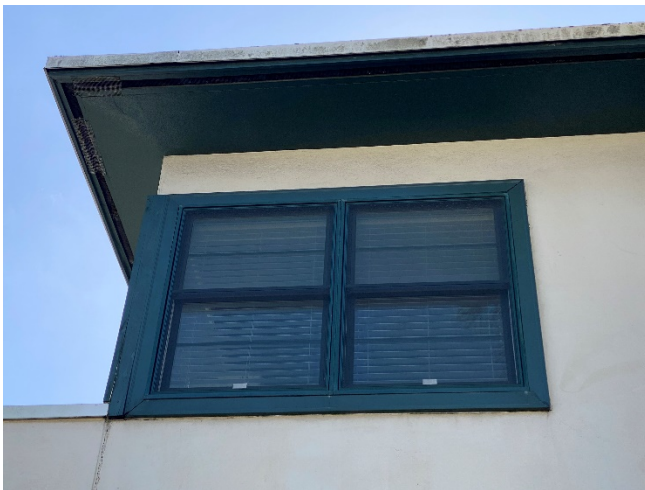
Window systems throughout the building envelop also vary widely. With the exception of one unit at the second floor, all the original historic wood windows have been replaced. Aluminum storefront framing and glazing with some ballistic rating are installed at the large openings in the City Commission Chambers along Ash Street. Double hung aluminum frame windows have been installed throughout the two-story volume of the

historic City Hall portion of the facility and the one-story additions on the east and south. Window framing is light-gauge and would be judged as performing poorly from a thermal perspective. The anodized aluminum finish is pitted and discolored. Windows in the second-floor addition have a factory or field painted green finish and applied wood trim surrounds. Projected sills are applied to the stucco wall finish in the historic portion of the building, while other conditions include recessed windows with sloped sill tops and no projections, or flush window frames with flat wood trim.

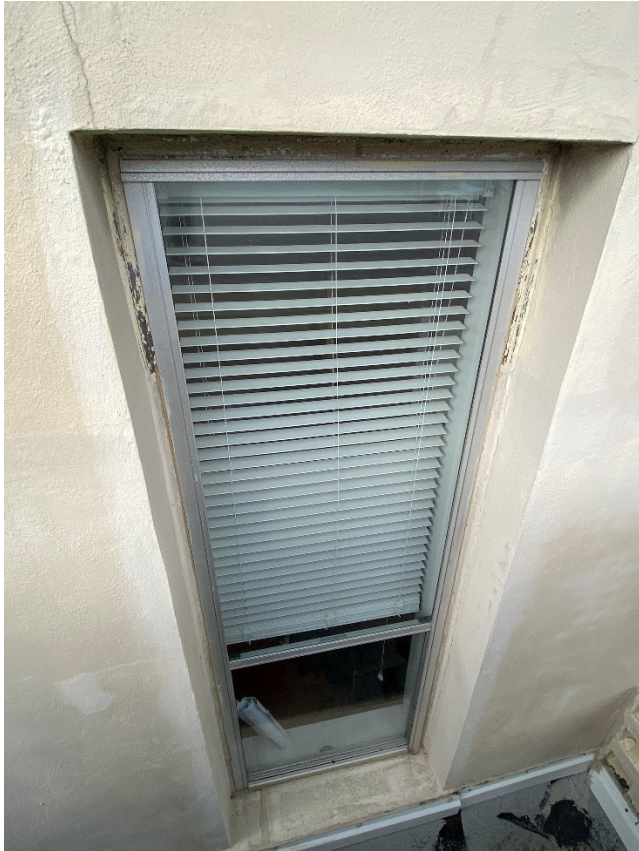
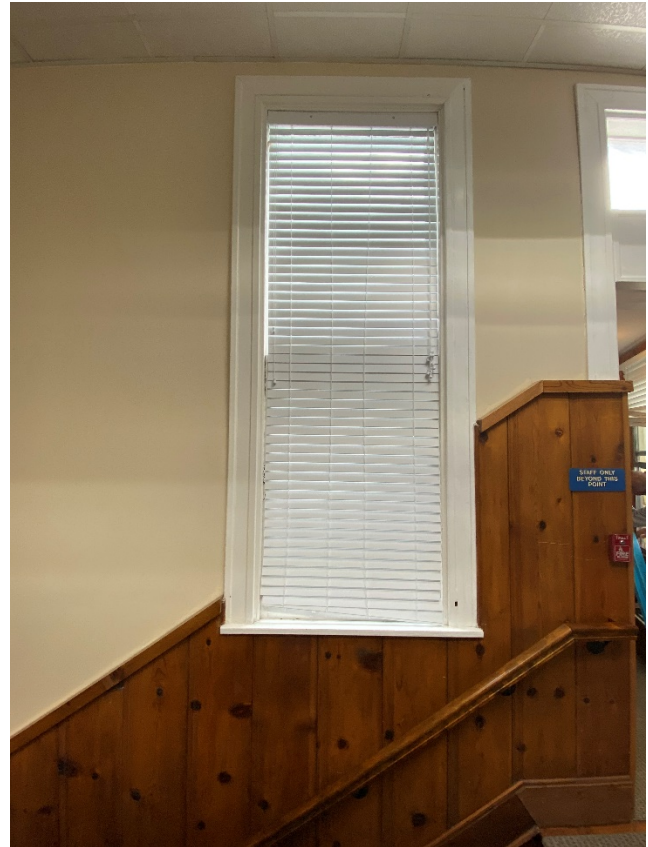
Care should be taken to preserve and protect the last remaining historic double-hung wood window located at the top of the monumental stair. An aluminum storm window has been applied to the exterior to improve thermal performance. The perimeter wood frame is exposed at the exterior and its painted coatings are failing.

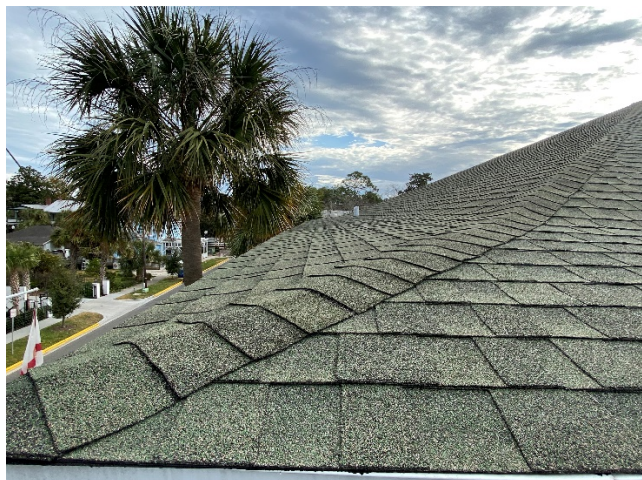
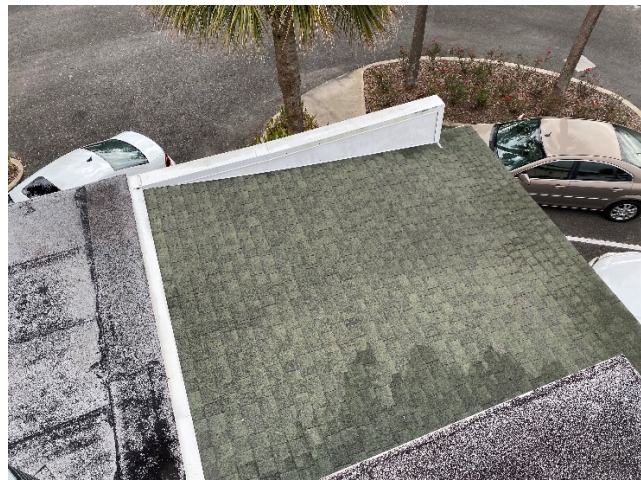
The hipped roof and shed roof are covered in an asphalt shingle system which appear to be in fair condition. Sloped roofs terminate at the eave with an aluminum trim over the wood fascia and do not shed runoff into a gutter and downspout system, but rather sheet-flow continuously at the perimeter.

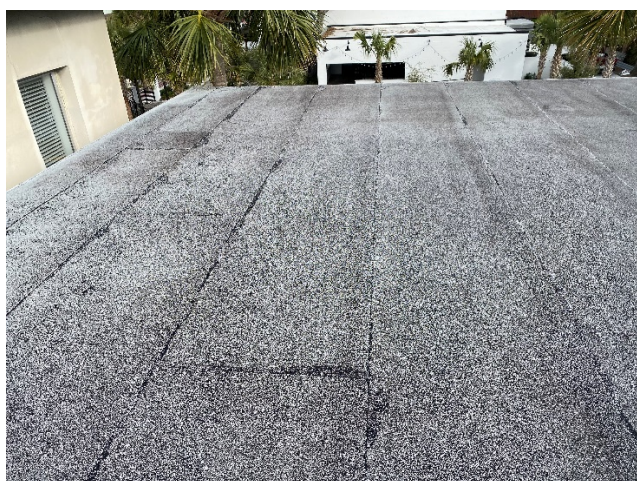
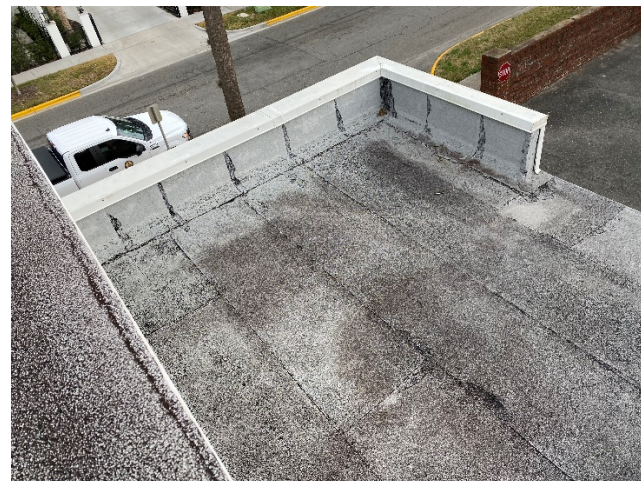
Low slope roof areas are covered in an asphalt roll roofing system with similar materials used to flash up against parapet walls and adjacent vertical wall surfaces. Low slope roofing terminates similarly with aluminum trims and lack gutters and downspouts to direct runoff.

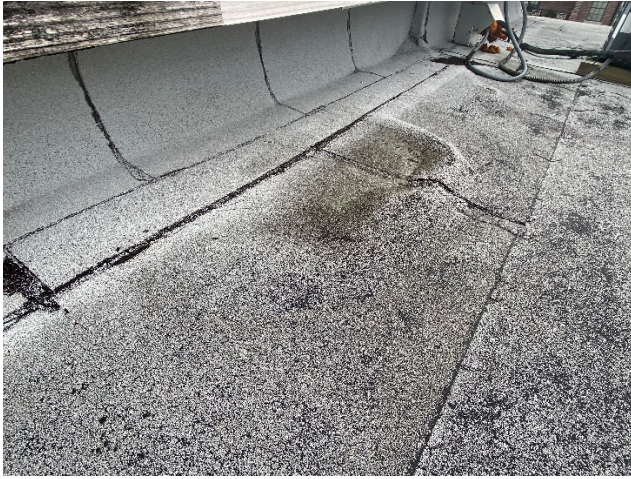
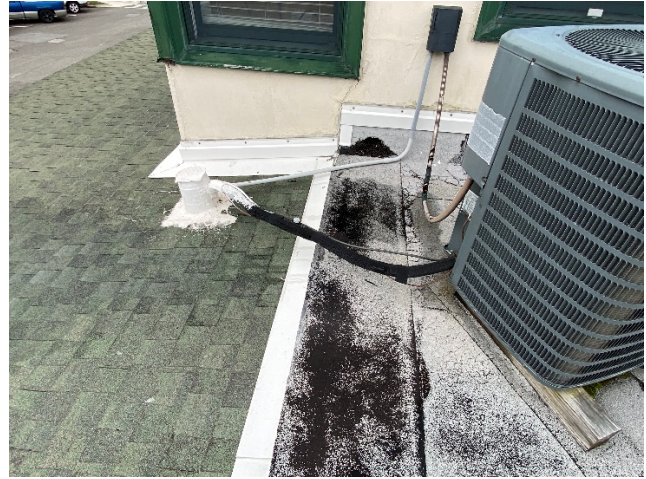
The asphalt roll roofing is in very poor condition and requires replacement. There are numerous pieces of mechanical equipment serving the building located on the roof, are supported on treated lumber. Penetrations in the roof and vertical walls for conduit and piping serving equipment is poorly sealed.

Based on the condition of the architectural roofing systems, it is assumed that they would be replaced. Selection of new and modern roofing membranes for low slope areas and more permanent and robust coverings for the hipped and shed roof areas can greatly improve the performance and maintenance needs of the facility while also contributing to the renewed or preserved architectural character of the building. Fluid-applied reroofing systems are currently being planned to address urgent building envelope maintenance issues. The planned fluid-applied repairs are not adequate to provide a lasting roof covering necessary for the long-term protection of a significant civic structure. Given the likely phasing of the renovations of the historic City Hall, it is prudent to continue modest repairs to protect the integrity of the structure and its contents.

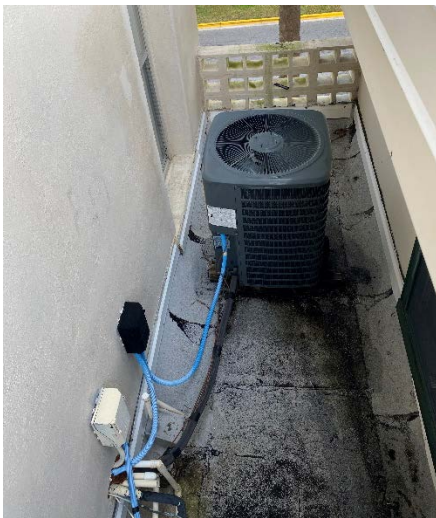
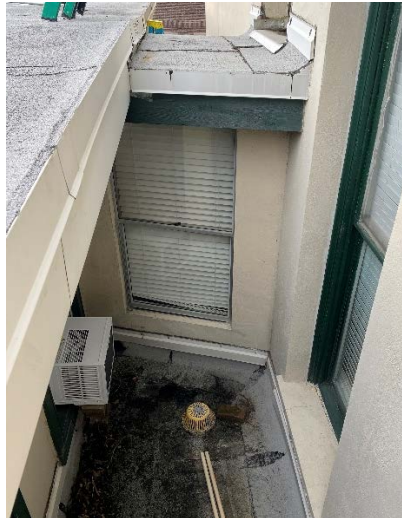
The low slope roofs of the one-story connection between the two two-story portions of the building also have serve as locations for mechanical equipment. These areas show signs of poor drainage to their perimeter edge or internal roof drains. Terminations of the asphalt roll roofing system are poorly detailed. Horizontal termination bars at the top of the vertical roll roof flashing have no counterflashing from the wall assembly and are mechanically fastened, primarily relying on sealants to keep water from getting below the roof covering. Where window sills are located at or just above the termination bar, sill flashing is needed.

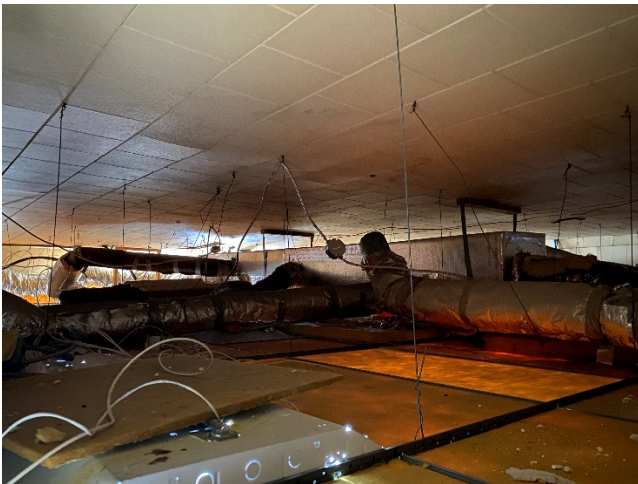
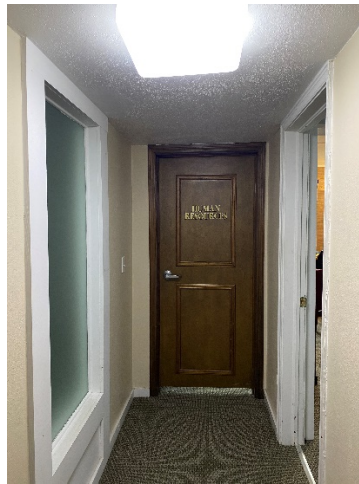
In areas of the second-floor addition above the historic fire state bay, interior ceiling heights of approximately 7'-0" above finish floor fall below the required interior ceiling height requirements of the Code.

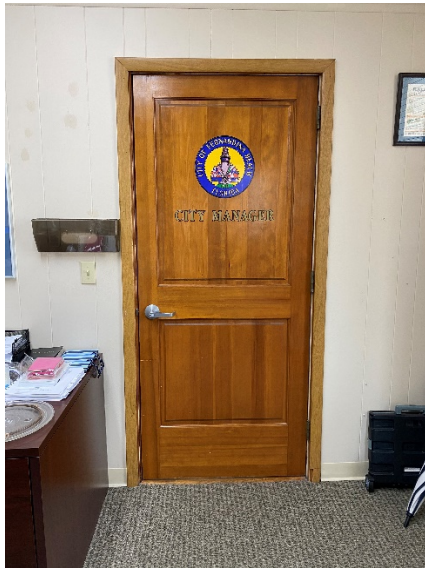
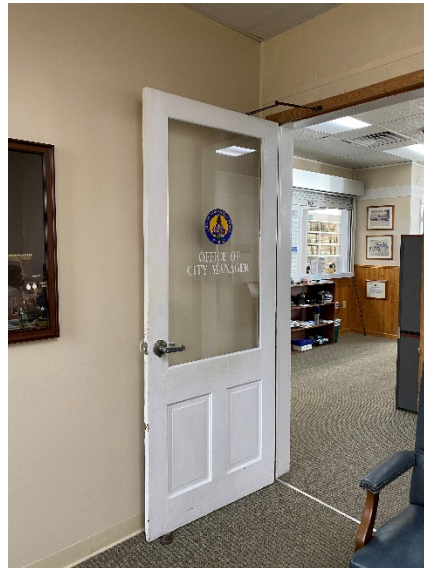
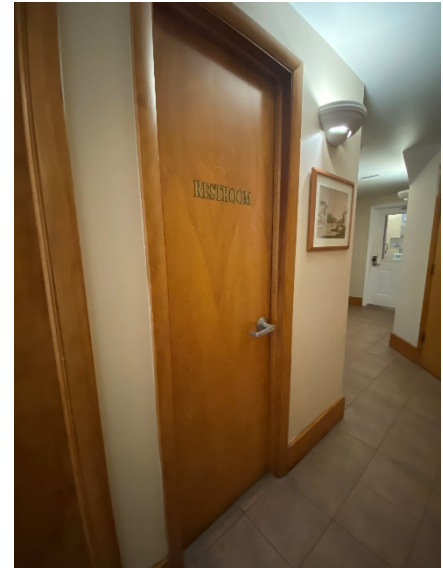
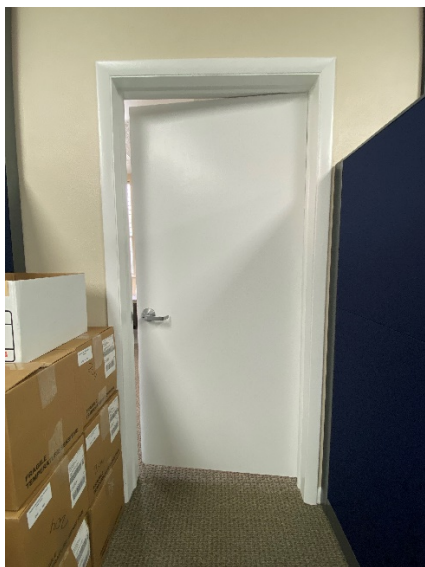
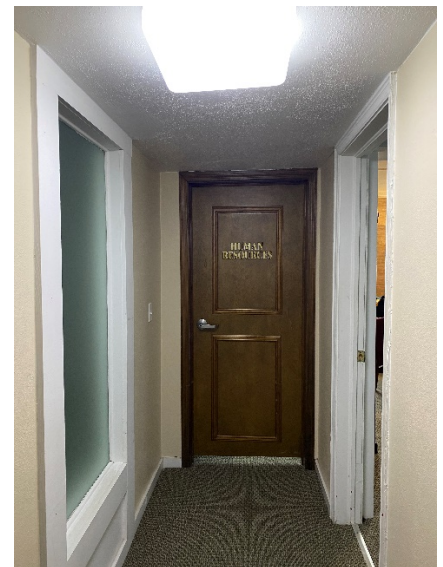
Interior door and frame systems vary widely throughout the facility. Door leaf widths and heights are not consistent, nor are the door panel configurations or painted / stained finishes. Likewise, door hardware consists of cylindrical locksets in a variety of lever styles and finishes.

While generally neutral in its palette, the interior design is aged and inconsistent throughout. Based on the condition, and primarily due to the likely need to significantly reconfigure the interior net usable space while also addressing Code issues of construction and compartmentation and required building support and infrastructure components, it is assumed that the vast majority of interior finishes will be removed and replaced if the existing City Hall is to undergo any meaningful renovation. Careful consideration should be given to historic conditions of the building and modern finish selections should work in compatibility with the building's design legacy.

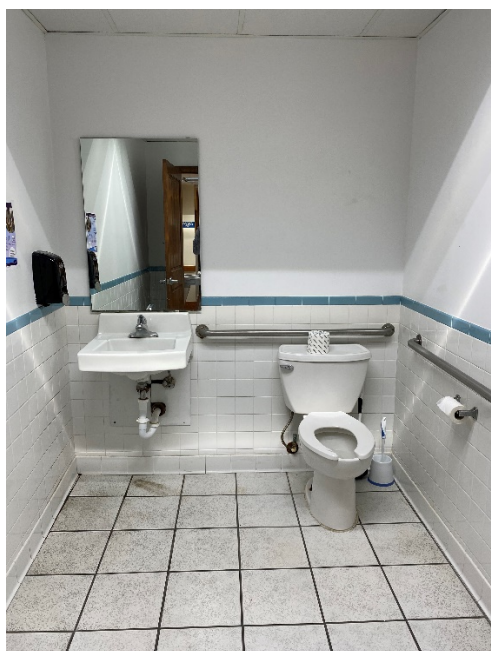
**FIG. 604.5.1**  
**SIDE WALL GRAB BAR FOR WATER CLOSET**

Regarding the existing accessible restrooms, the room widths of 6'-2" is minimally adequate to accommodate the horizontal layout of fixtures, clear floor areas, and grab bars. However, the grab bar configurations do not provide the 18-inch vertical bar required by current accessibility standards as illustrated below.

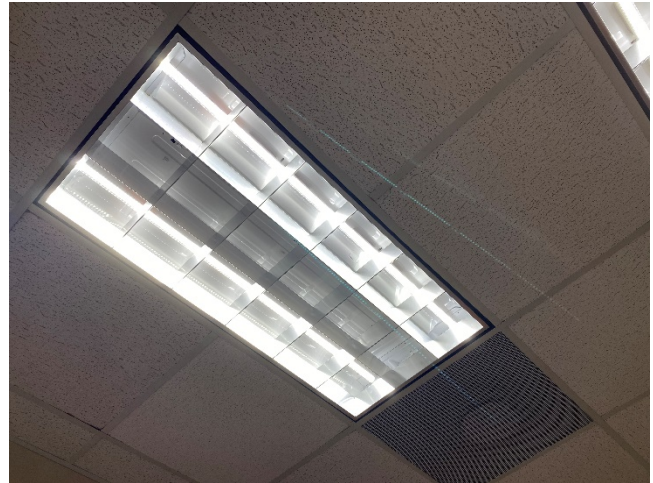
Most, if not all of the light fixtures that were originally fluorescent or incandescent fixtures have been retrofitted to use LED retrofit light bulbs. Although this can be an effective way to reduce energy and maintenance costs, the aesthetics and photometric performance often suffer. In the examples above and below, the center row of parabolic cells and acrylic fixtures are dark, giving an inconsistent appearance to the fixture. The “can” type fixtures have more effective retrofitted LED bulbs that work effectively, providing good lighting and a more appropriate look.

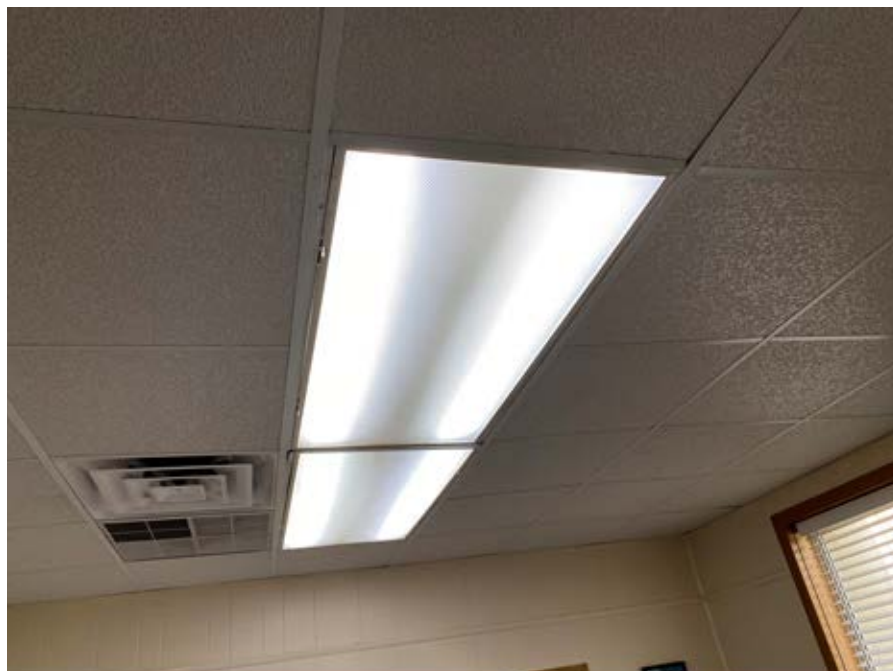
The electrical service comes from a transformer bank, on a riser pole across the street to the southeast of the property. The 3-phase, 120/240-volt service goes underground at the riser pole and stubs up into the service entrance room on the south side of the building. The service entrance room for the electrical service is also shared with the communications service and water service. The room is inappropriately used as a storage room as well.

The main distribution panel is beginning to show its age and should be replaced with any renovation stemming from this project. Spare parts may be difficult to find if breakers begin to fail. Or if it is attempted to reuse this panel in the renovations. Operating the breakers many times for disconnecting and reconnecting can cause permanent failures in equipment this old and showing this much corrosion.

The electrical service room is among the spaces that are to be demolished to bring the building back to its historic conditions. Demolishing this room will require the entire electrical service to be re-routed and the equipment to be replaced.

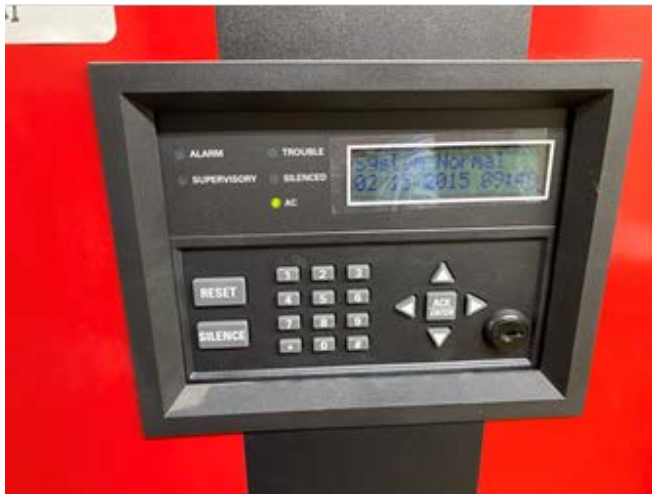
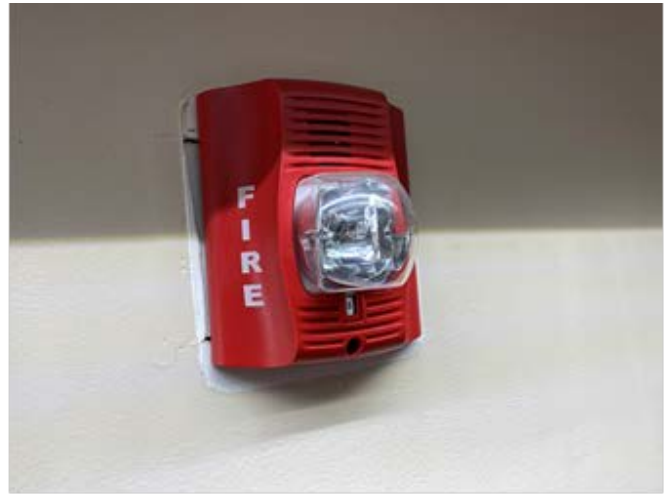
The building's life-safety systems appear to be operating effectively. These include the fire alarm system and the emergency lighting fixtures. The fire alarm system appears to have been replaced within the last 5-10 years and is a Silent Knight SK-5208 system which is still available on the market and serviceable.

System components appear to be provided and located to meet the requirements of the NFPA. This system should be able to be reconfigured to work for the new building configuration.

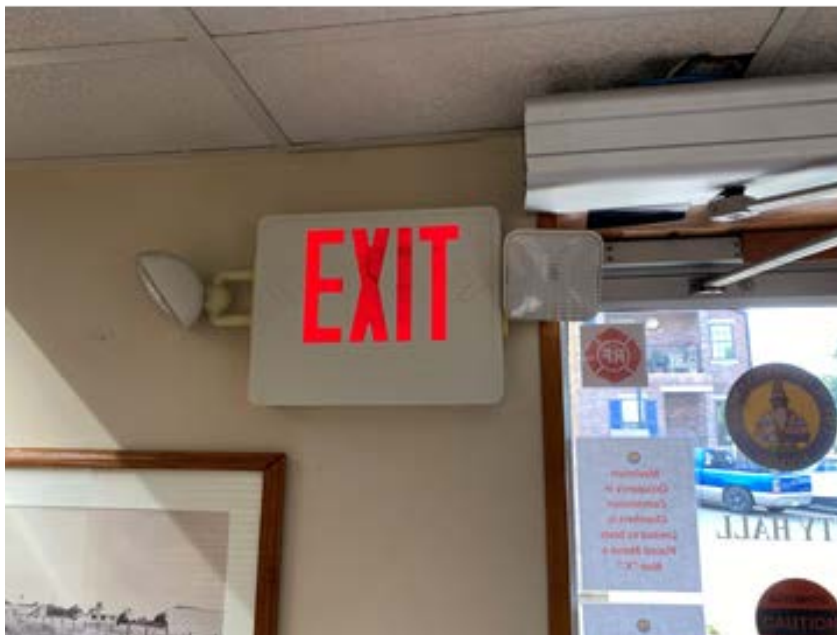
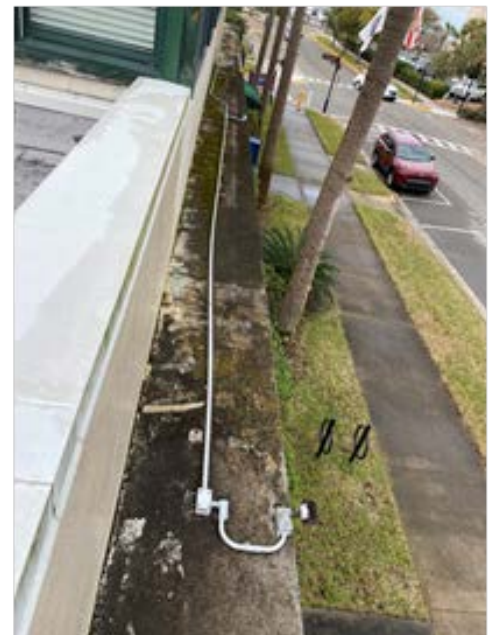
The building emergency lighting is provided by EXIT signs with built-in emergency lights and other battery backed up light fixtures in the paths of egress. Surface mounted conduit and light fixtures have been added over time to provide lighting at the building exits. It was unclear whether these fixtures were served from an emergency backup source as the current codes would require and will be required in the new building arrangements.

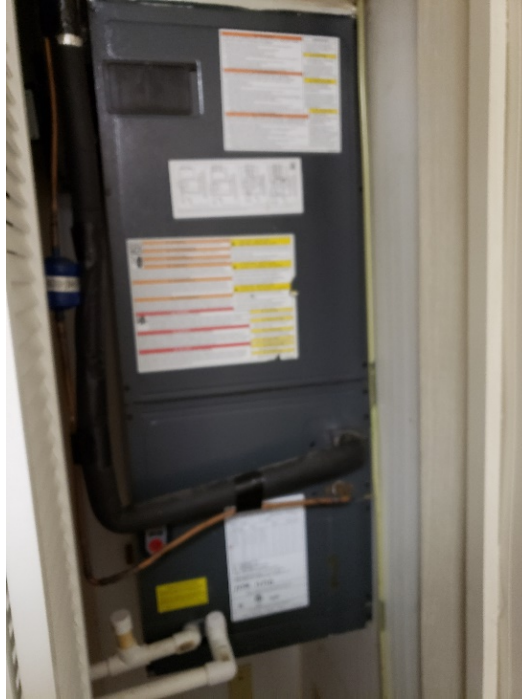
Some units lack ventilation air, which is in violation of the Florida Mechanical Code, and ASHRAE Standard 62.1. This deficiency would need to be rectified by ducting outside air to the remaining units and reconfiguring their return systems. See picture below.

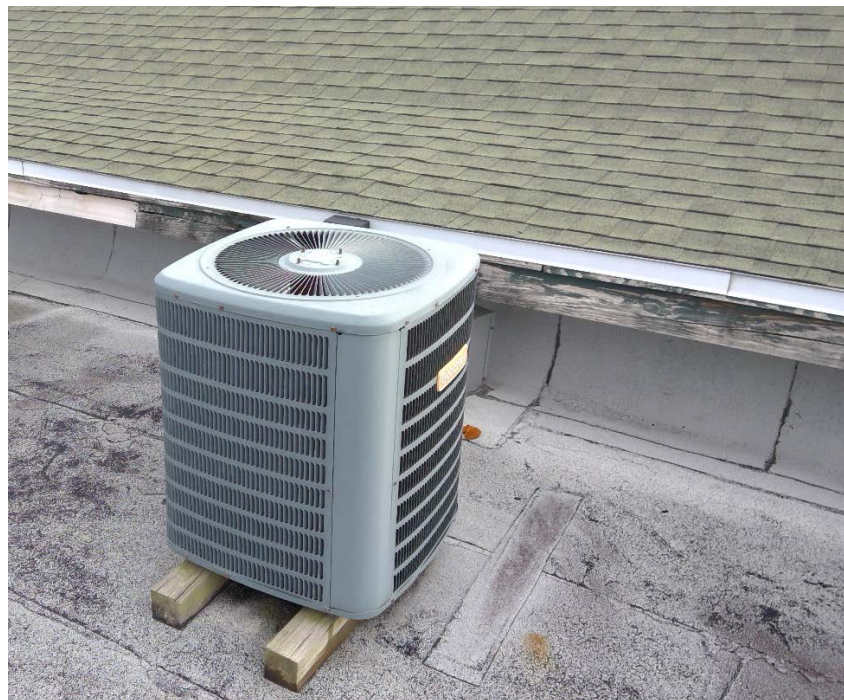
The condensing units located on the roof are currently supported by 4x4 wood “sleepers”. See picture below. This does not allow the Code required clearance for re-roofing below the units and also does not provide the necessary wind load resistance. For the units to remain, new roof curbs should be installed to elevate them above the roof. Additionally, tie-downs should be installed from the condensing units to the structure below to resist wind loads.

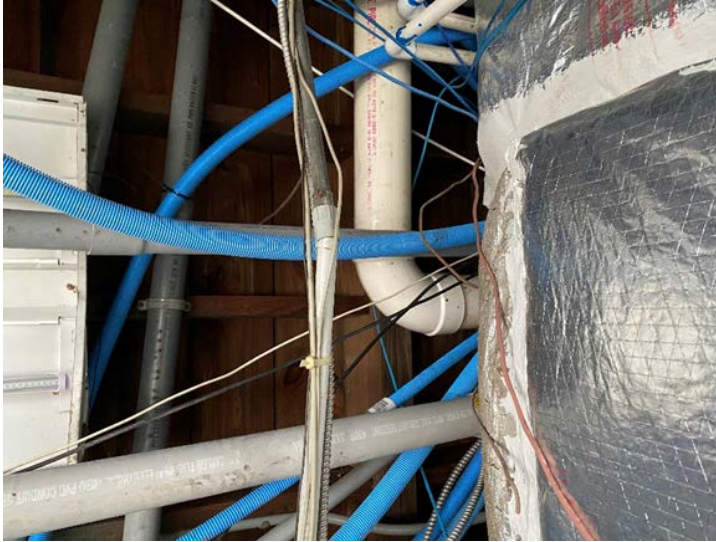
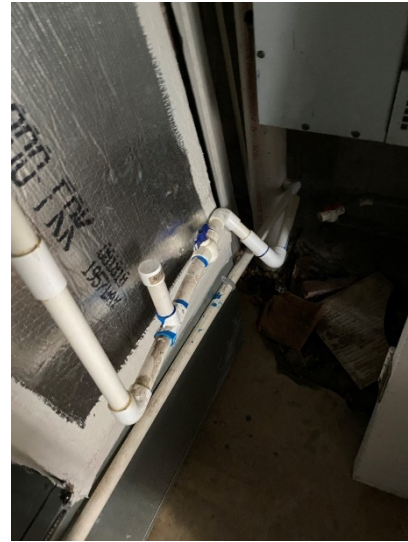
There currently is a combined service entrance room where the electrical, communications and water services all enter the building. There are pipes installed above electrical panels that should be moved. There is a drainage pipe from the existing mechanical equipment in the same room that is currently discharging onto the ground within this room that needs to discharge outside of the room.

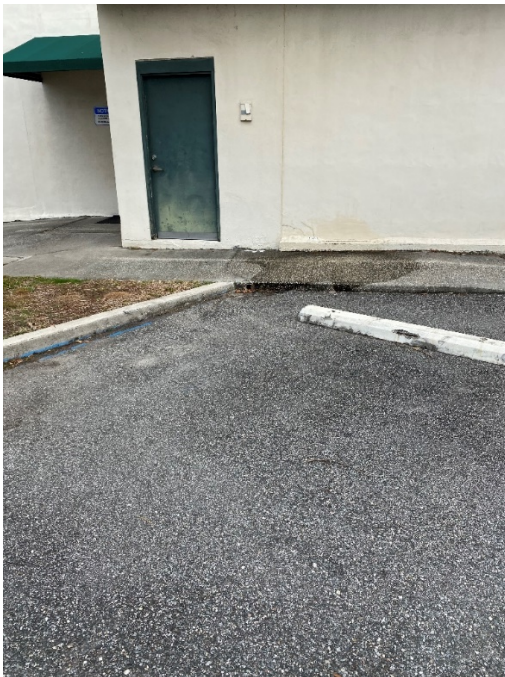
The existing storm drain on the lower roof is being routed vertically in the electrical room and discharging onto the parking lot surface. The pipe needs to be rerouted outside of this room.
