**AGENDA**  
**CODE ENFORCEMENT & APPEALS BOARD HEARING**  
**MAY 2, 2018**  
**5:30 PM**  
**CITY HALL COMMISSION CHAMBERS**  
**204 ASH STREET**  
**FERNANDINA BEACH, FL 32034**

- 3.1 **RICHARD GOODSSELL, FRONT STREET PROPERTY LLC, 101 NORTH 2ND STREET, CASE 18-00044.** Violation(s) of the City of Fernandina Beach Code of Ordinances exist: Section 42-116 (a & b), cleaning of lots; maintenance of structures. *Requesting Board determination of the case.*

This property has been on the City's radar for quite some time, years. Many conversations have transpired between the City and Mr. Goodsell over the last few years about the condition of the building and the future of this property.

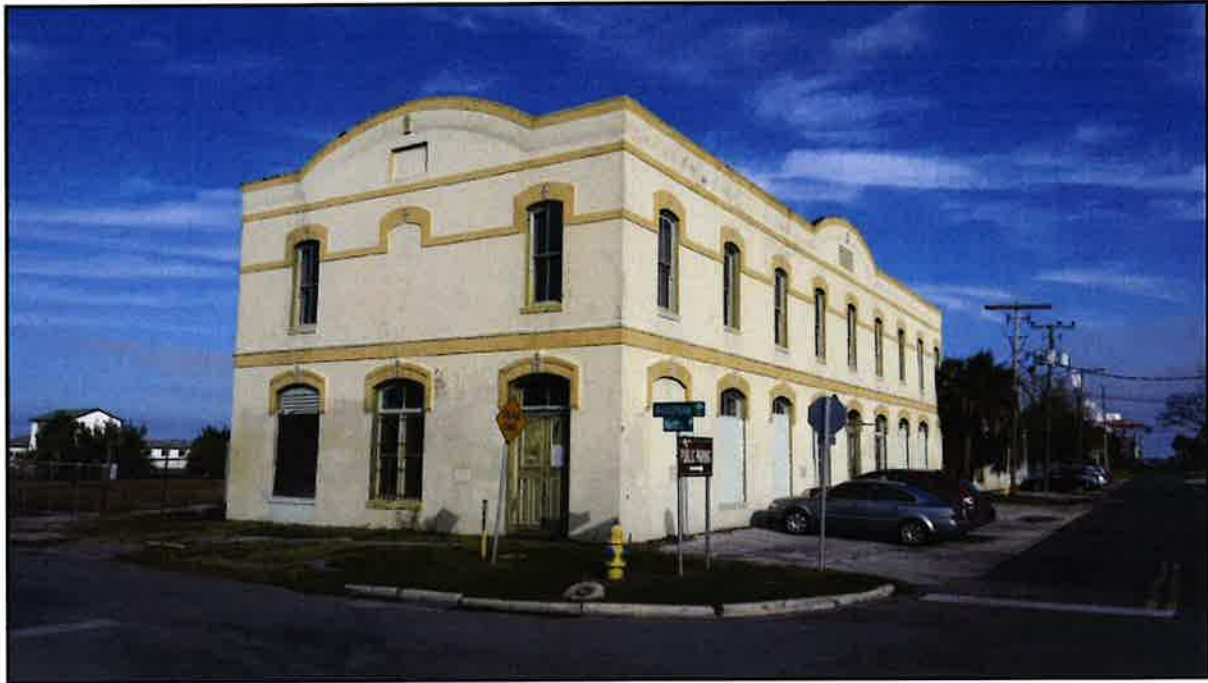
Photo 1 – Southeast corner of building.

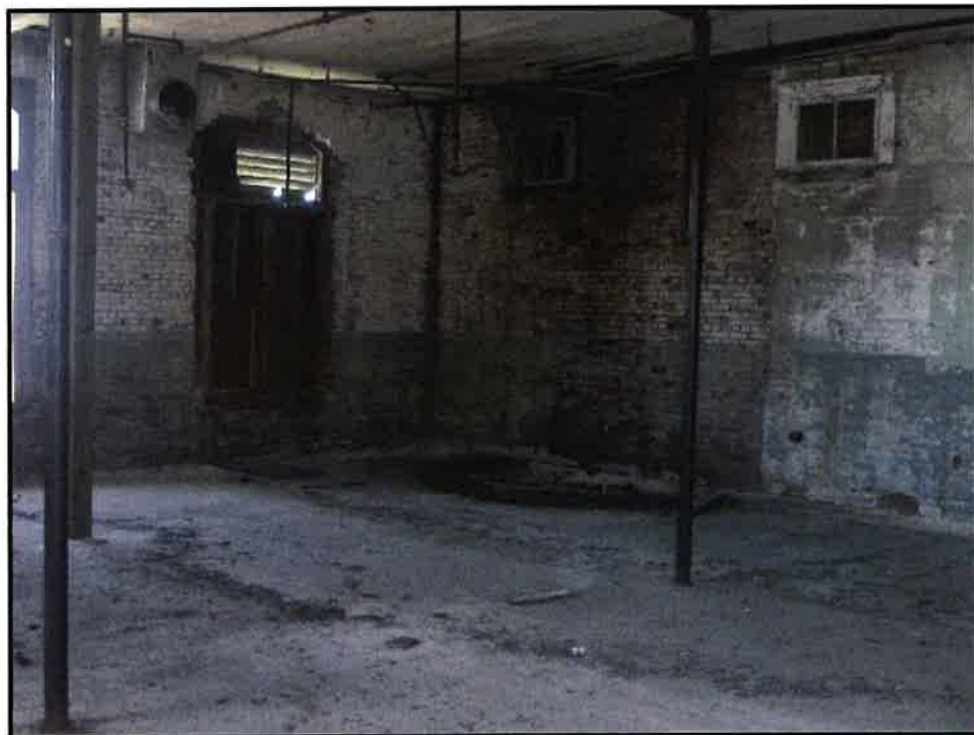
Photo 2 – First floor showing ceiling damage and where water has pooled.

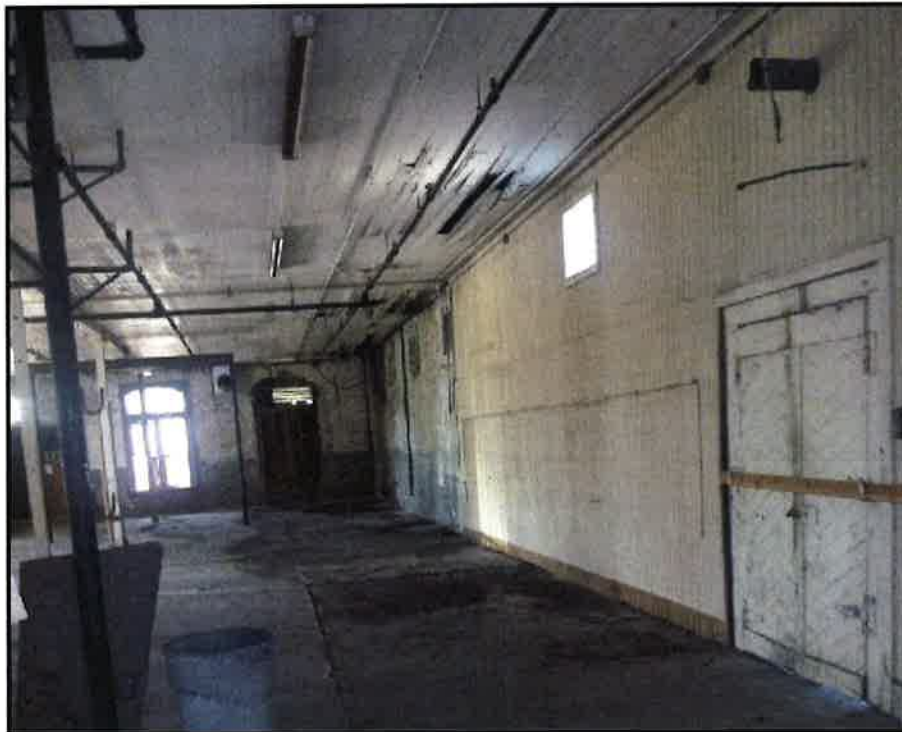
Photo 4 – Wider view of first floor with ceiling damage.

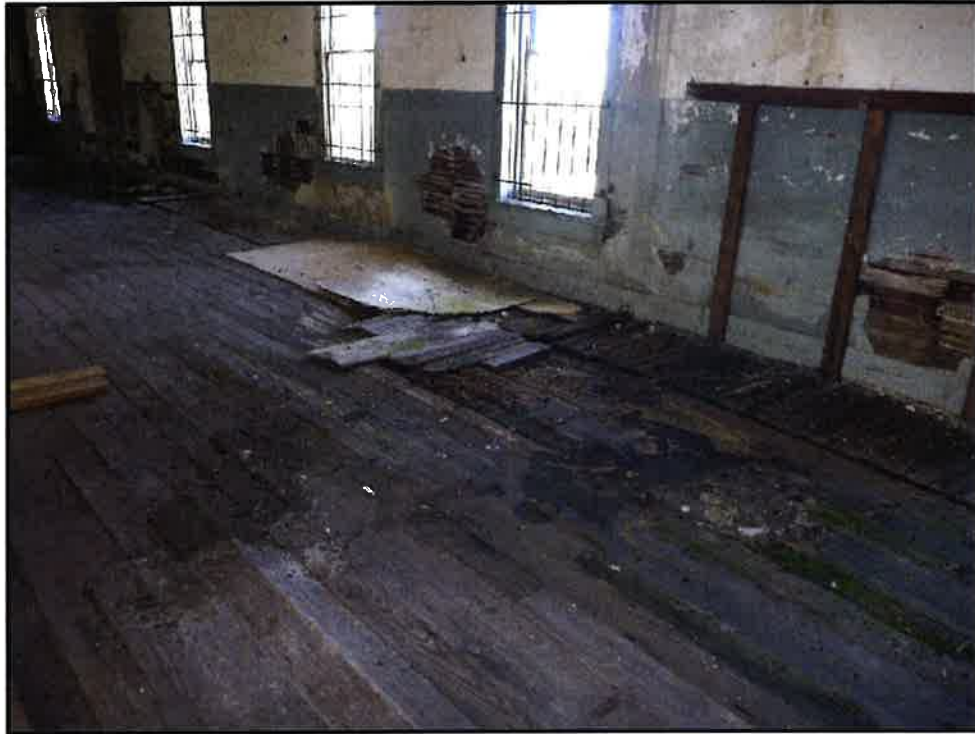
Photo 5 – Second floor damage due to water intrusion.

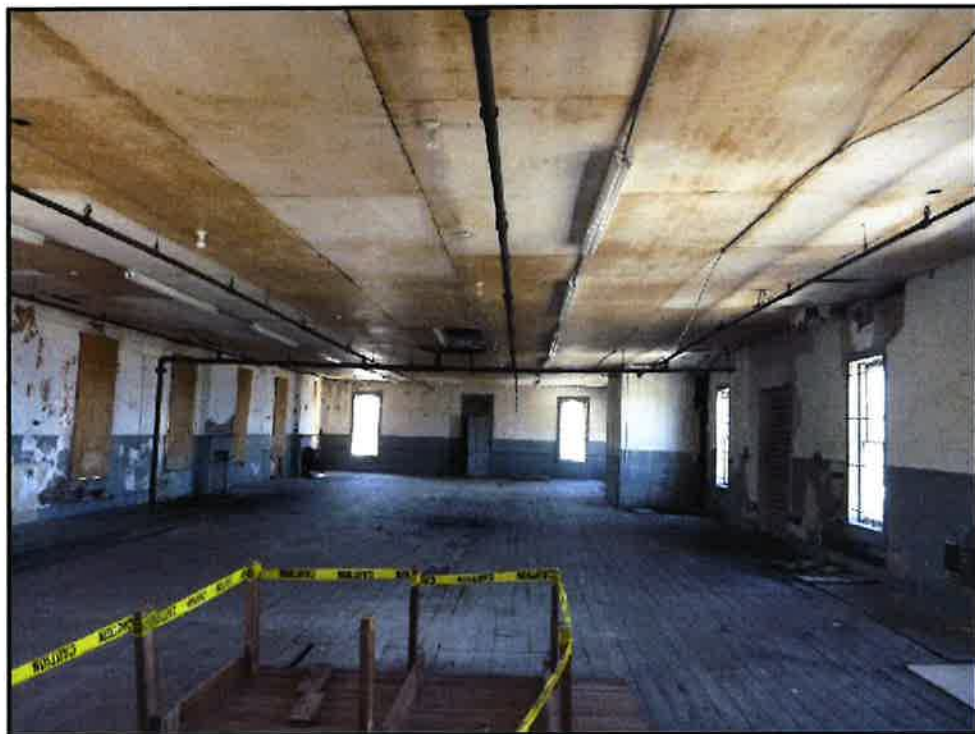
Photo 6 – Wider view of second floor.
