**AGENDA  
AIRPORT ADVISORY COMMISSION  
REGULAR MEETING  
NOVEMBER 14, 2019  
6:00 PM  
CITY HALL COMMISSION CHAMBERS  
204 ASH STREET  
FERNANDINA BEACH, FL 32034**

# Executive Summary

Fernandina Beach Municipal Airport was inspected in May of 2019 – the overall weighted PCI value was 69, a condition rating of Fair. The results of the maintenance, repair, and major rehabilitation analysis identified \$759,600 in localized M&R needs based on current conditions and a 10-Year major rehabilitation need of \$12,252,000 based on forecasted conditions. The current major rehabilitation needs based on the latest inspection consist of \$9,939,000 for pavements below critical condition.

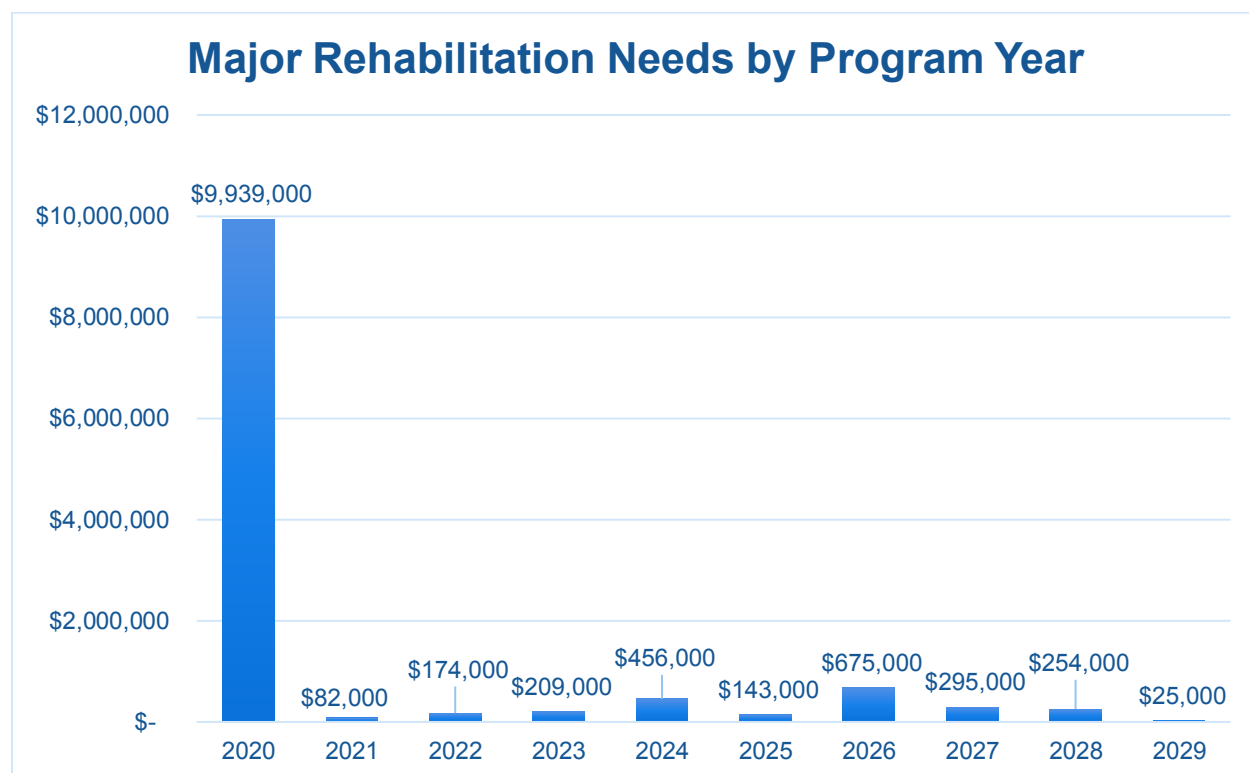
*Figure 6.3.1 (a) 10-Year Major Rehabilitation Needs by Program Year*

The following **Figure 6.3.1 (a)** summarizes the section-level major rehabilitation needs for a 10-year period between 2020 and 202\*. **Figure 6.3.1 (b)** provides an inset view of Airfield Pavement Major Rehabilitation Exhibit, a large format exhibit is located in **Appendix C Technical Exhibits**. The exhibit graphically depicts the Major Rehabilitation Needs with rounded costs.
