**AGENDA  
BOARD OF ADJUSTMENT  
REGULAR MEETING  
SEPTEMBER 15, 2021  
5:00 PM  
CITY HALL COMMISSION CHAMBERS  
204 ASH STREET  
FERNANDINA BEACH, FL 32034**

**MINUTES  
BOARD OF ADJUSTMENT  
REGULAR MEETING  
AUGUST 18, 2021**

**RE:** **Waterfront Stabilization Analysis and Building Condition Assessment of Brett's Waterway Café – Amelia Riverfront Resiliency Study**

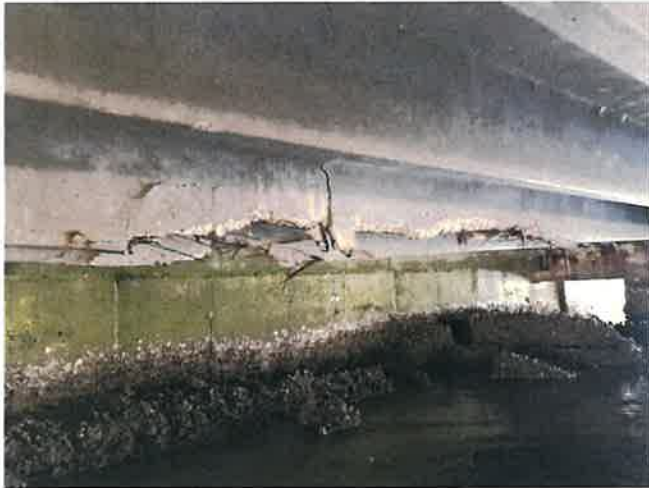
*Photo 2653*

- Exposed prestressing strands of the double tee showing severe deflection (Photos 2653, 2654, 2663, 2672)

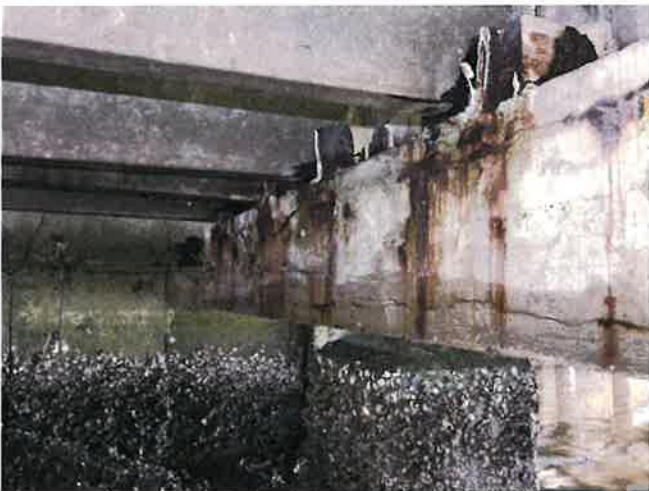
Photo 3320

- Showing severe spalling of concrete beam (Photos 2682, 2684, 2686, 3320, 3324)

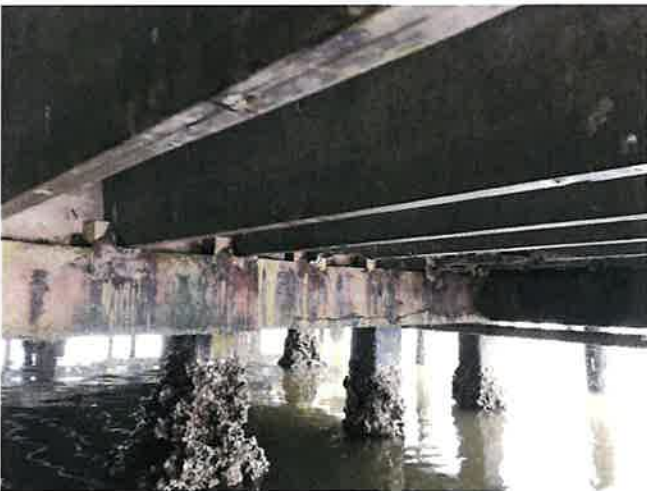
Photo 2804

- It appears that wood form boards were not removed after repair of concrete beam. (Photo 2796)
- Cracks in concrete beam and deteriorating metal plates (Photos 2799, 2804, 2831)

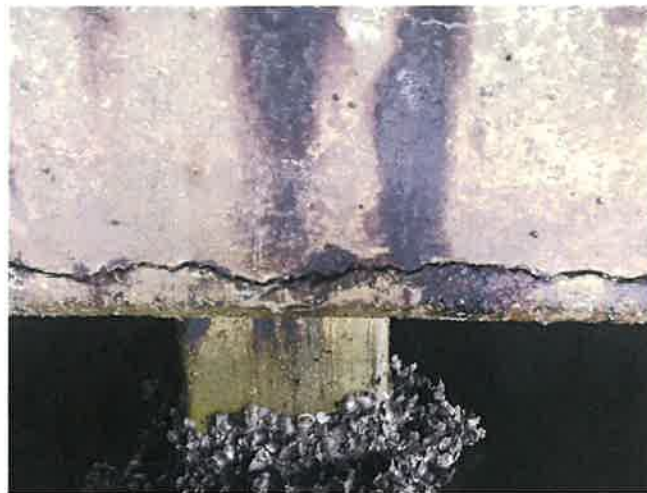
Photo 2459

- Cracks in concrete beam (Photos 2454, 2456, 2459, 2500, 3219)
