**AGENDA**  
**CODE ENFORCEMENT & APPEALS BOARD HEARING**  
**MAY 2, 2018**  
**5:30 PM**  
**CITY HALL COMMISSION CHAMBERS**  
**204 ASH STREET**  
**FERNANDINA BEACH, FL 32034**

- 3.1 **RICHARD GOODSSELL, FRONT STREET PROPERTY LLC, 101 NORTH 2ND STREET, CASE 18-00044.** Violation(s) of the City of Fernandina Beach Code of Ordinances exist: Section 42-116 (a & b), cleaning of lots; maintenance of structures. *Requesting Board determination of the case.*

This property has been on the City's radar for quite some time, years. Many conversations have transpired between the City and Mr. Goodsell over the last few years about the condition of the building and the future of this property.

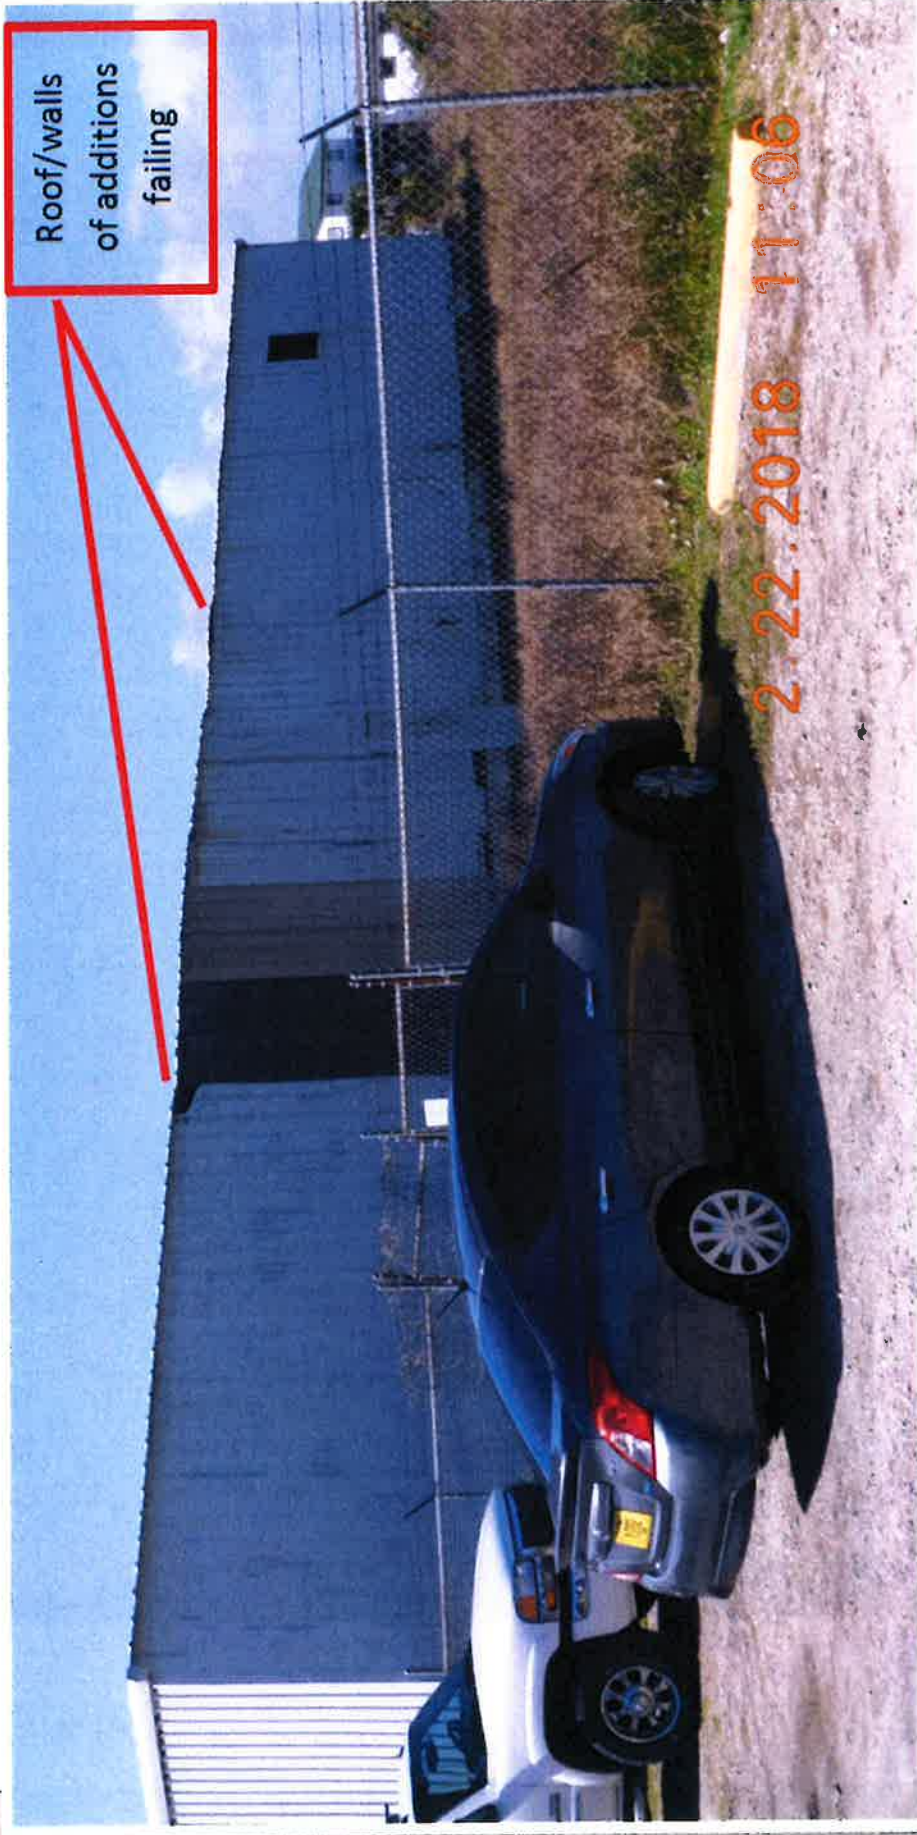
Broken/  
missing  
window  
panes

Paint failure  
on walls and  
wood  
elements

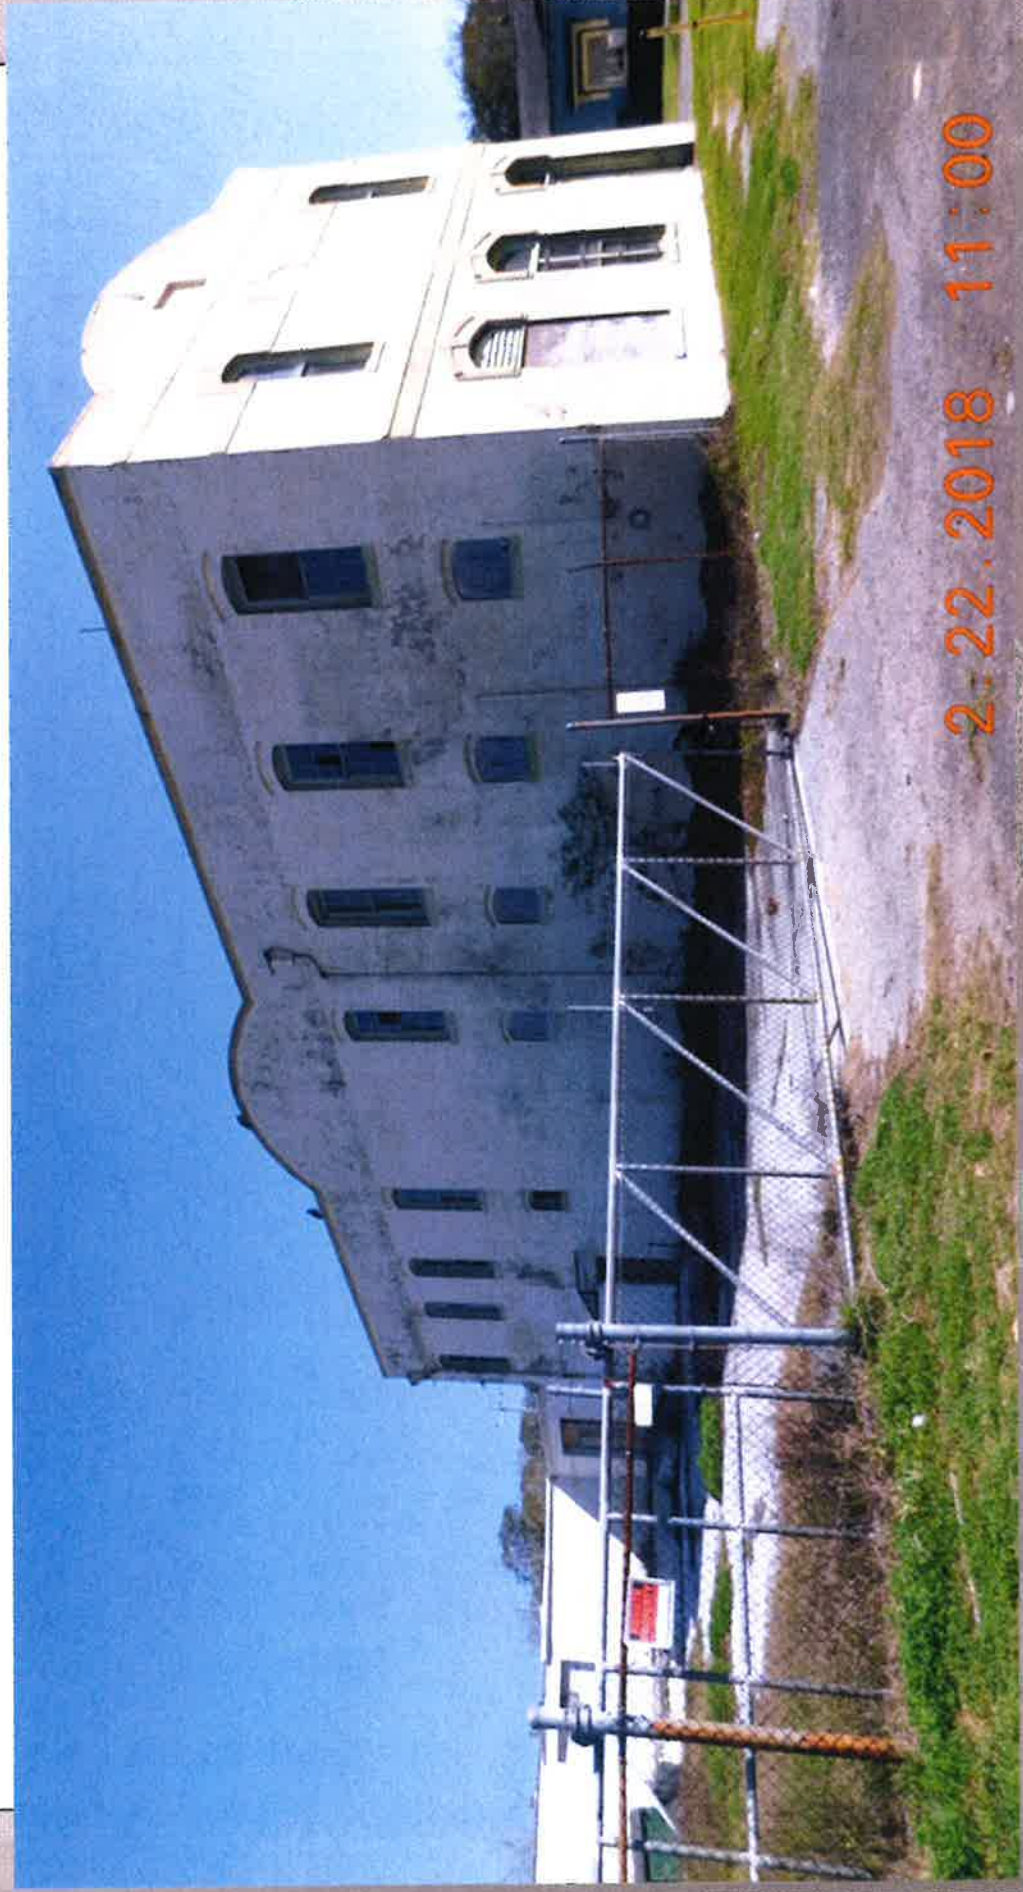
Paint failure  
on walls and  
wood  
elements

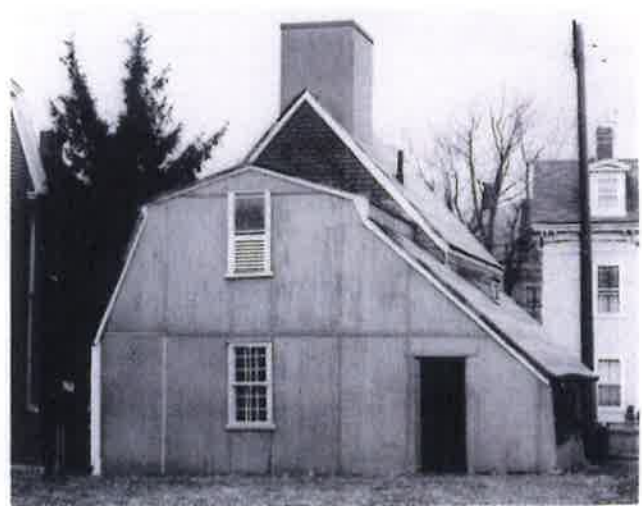
*Temporary stabilization or "mothballing" with materials such as plywood and building paper can protect the roof of a project until it can be properly repaired or replaced. (Narbonne House, Salem, Massachusetts)*

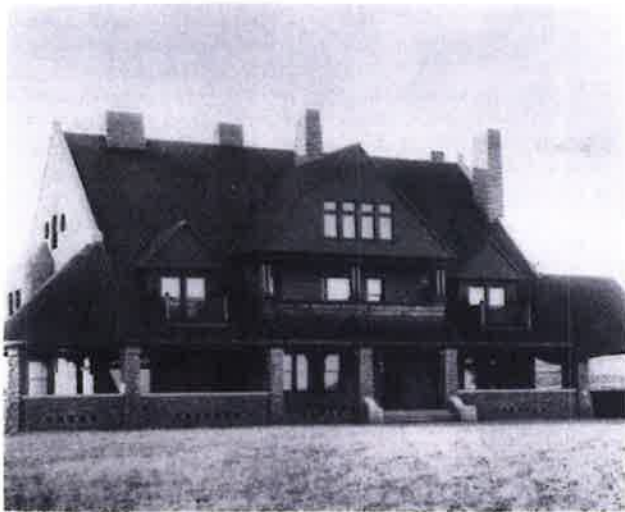
*These two views of the same house demonstrate how the use of a substitute material can drastically affect the overall character of a structure. The textural interest of the original tile roof was lost with the use of asphalt shingles. Recent preservation efforts are replacing the tile roof. (Frank House, Kearney, Nebraska, photo courtesy of the Nebraska State Historical Society, Lincoln, Nebraska)*

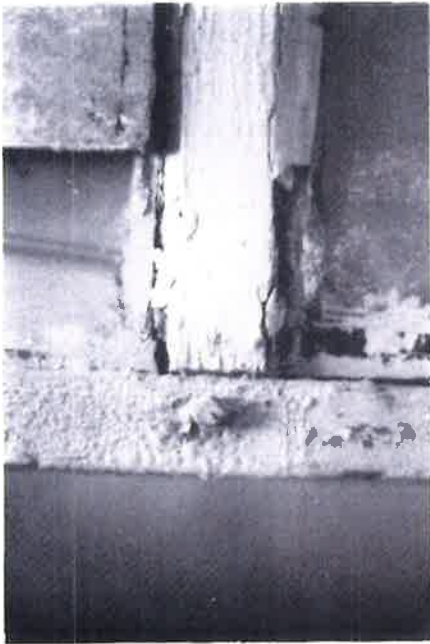
Figure 4a. The following series of photographs of the repair of a historic double-hung window use a unit which is structurally sound but has many layers of paint, some cracked and missing putty, slight separation at the joints, broken sash cords, and one cracked pane. Photo: John H. Myers

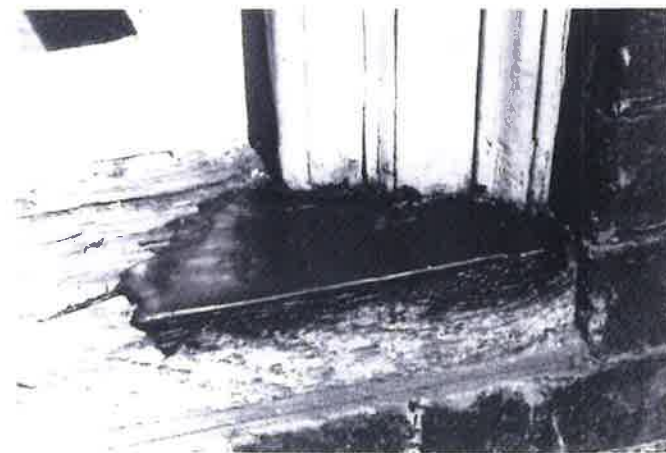
Figure 5. This illustrates a two-part epoxy patching compound used to fill the surface of a weathered sill and rebuild the missing edge. When the epoxy cures, it can be sanded smooth and painted to achieve a durable and waterproof repair. Photo: John H. Myers

Wood may also be strengthened and stabilized by consolidation, using semi-rigid epoxies which saturate the porous decayed wood and then harden. The surface of the consolidated wood can then be filled with a semi-rigid epoxy patching compound, sanded and painted (see figure 5). Epoxy patching compounds can be used to build up
